PERFORMANCE AUDIT REPORT ON MANAGEMENT OF ROADS FURNITURE

The Ministry of Works, Transport and Communication and
Tanzania National Roads Agency

A REPORT OF THE CONTROLLER AND AUDITOR GENERAL

MARCH 2017

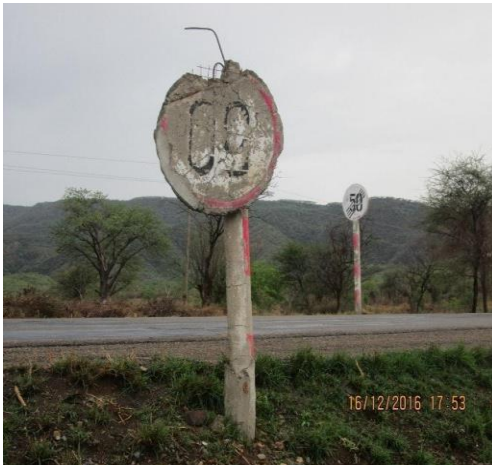
Photo 3.1 Reinforced concrete sign captured by auditors along TANZAM Highway at Igawa-Mbeya section on 16/12/2016

The uses of concrete materials for road signs hinder the visibility as they are not reflective and can increase severity in the event of accidents. These signs do not comply with the requirement of a Guide to traffic signing 2009 and the Standard Specification for Road Works, 2000. Audit team had observed most faded signs along Chalinze-Segera-Tanga, Morogoro -Dodoma and Mbeya -Lwanjilo-Chunya. The most faded signs include regulatory signs for speed limits. **Photo 3.3** and **3.4** below shows faded signs.

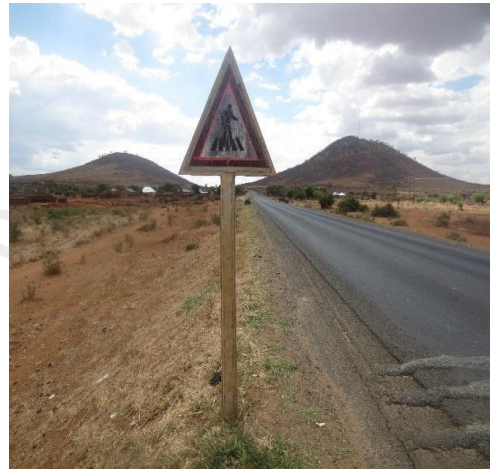
Photo 3.2 Reinforced concrete sign captured by auditors on December 13, 2016 at Wilunze Makalavati village along Dodoma- Morogoro road (57km) RHS from Dodoma

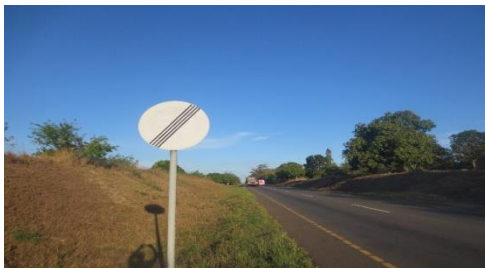
Photo 3.3: Fainted signs Captured on December 13, 2016 along Seger - Tanga road

Audit found that, the faded signs were not made from sheets of the appropriate colour or did not use coloured overlay film onto white sheets as required by Standard Specification for Road Works, 2000. The paint and sheets were substandard and so they faded when exposed to the sun. Therefore, the signs are not serving the intended purpose.

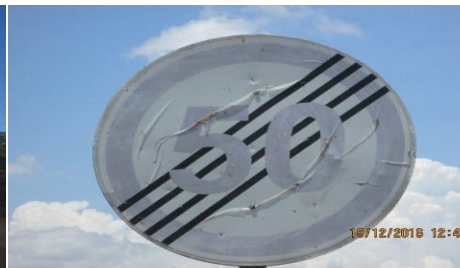
Photo 3.4: Fainted signs captured on December 19, 2016 along Mbeya-Lwanjilo-Chunya road

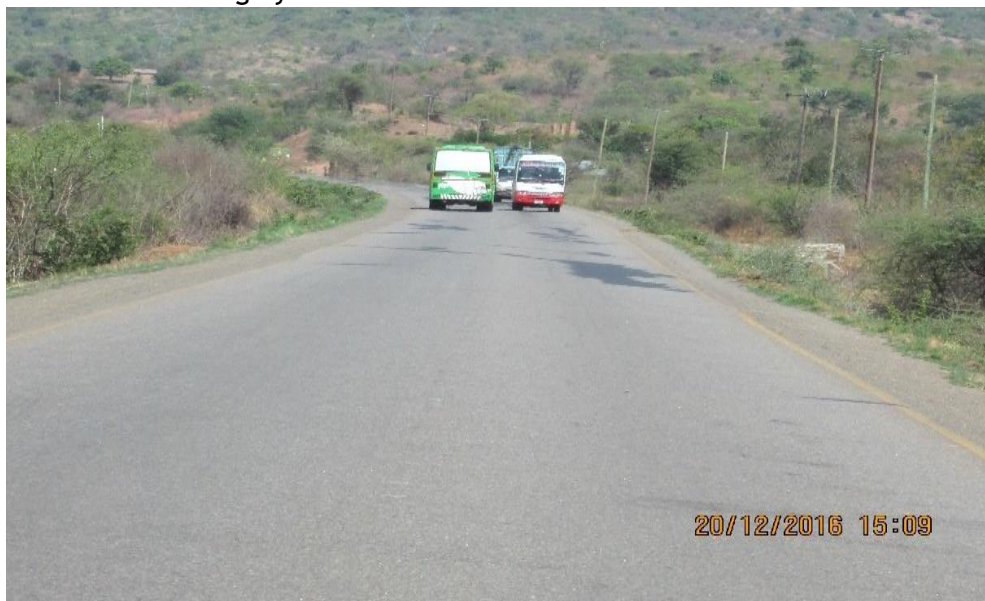
In all eight visited roads, road markings mainly; centreline and edge yellow acoustic lines, had dis-appeared or faded to the extent that they are not seen easily. Worn-out road markings were mostly found on Dar-Chalinze, Morogoro-Dodoma and Iringa-Mbeya (Igawa-Mbeya section) roads. The audit noted that, the paint used for the markings was not reflectorized as per standards/specifications. It is not known whether this is due to supervision weakness. The use of substandard paints increases frequency of maintenance by TANROADS which implies more maintenance cost.

Also, the worn-out centreline inhibits separation of traffic movement, while the worn-out edge yellow line inhibits separation of motorized and non- motorized road users. All these shortcomings contribute to the increased risk of road accidents. Photo 3:5 below shows the worn-out centreline and edge yellow acoustic line.

Photo 3.5 Worn out road markings along TANZAM Highway (Igawa-Mbeya) road captured by auditors on 20.12.2016

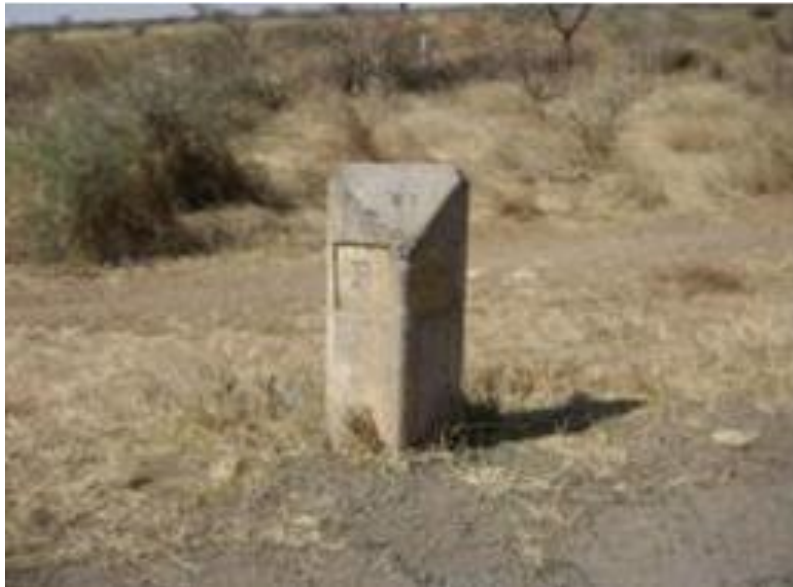
In addition, the audit observed kilometre marker posts without any letters and numbers to show the distances to the next town/centre (see **Photo below**).

Photo 3.6 Kilometre marker post seen along TANZAM Highway

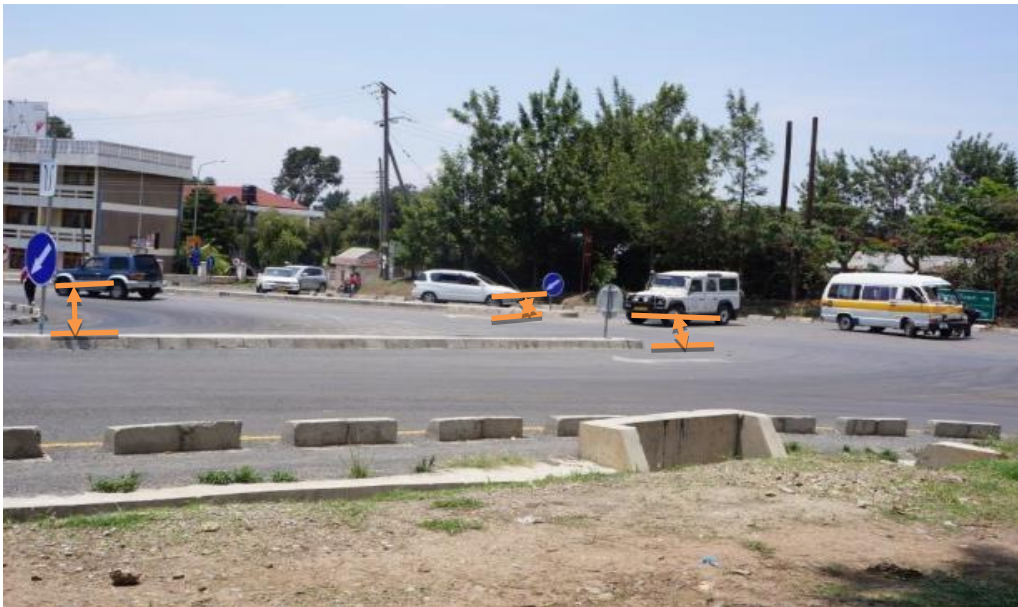
Photo 3.7 Short informative signs observed at Mbeya city staggered junction
Km 0:00 at Mbeya -Lwanjilo-Chunya

The observed signs were shorter than the required 1.8m above ground level as per standards. One of these signs is on the beginning of Mbeya-Lwanjilo-Chunya road (km 0.00). Some road sign poles are protruding above the sign plates.

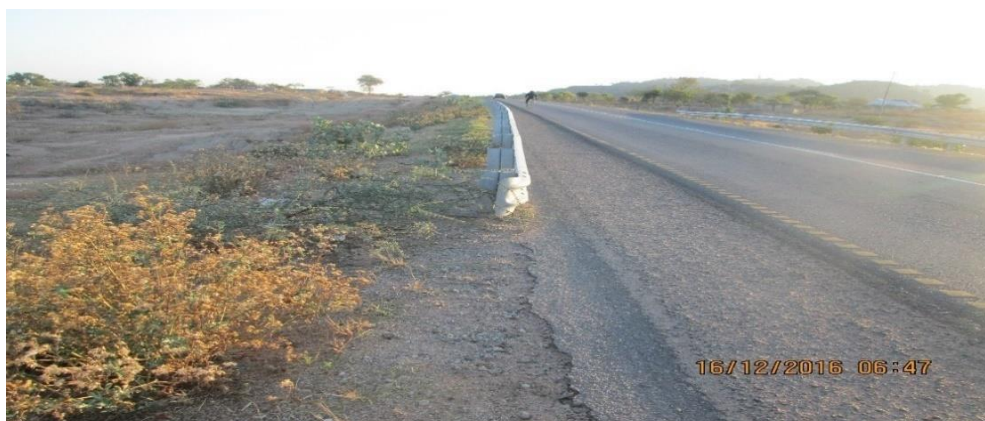
The audit noted guard rails with projecting ends i.e. fish tails not buried nor had concrete end blocks along Dar-Chalinze, Morogoro-Dodoma and Iringa-Mbeya (Igawa-Mbeya section) roads. This is contrary to the Standard Specification for Road Works, 2000. Most of these guard rails had no reflective plates which make them not clearly visible to the road users during the night. As the result, they increase the risk of fatality of road traffic crashes especially during night. Also, they endanger safety of other road users such as pedestrians and pedal cyclists. **Photo 3.8** below is an example of substandard erected guard rails.

Photo 3.8 Protruding start of guardrail fishtail along Iringa - Dodoma road.
Captured by Auditors on 16/12/2016

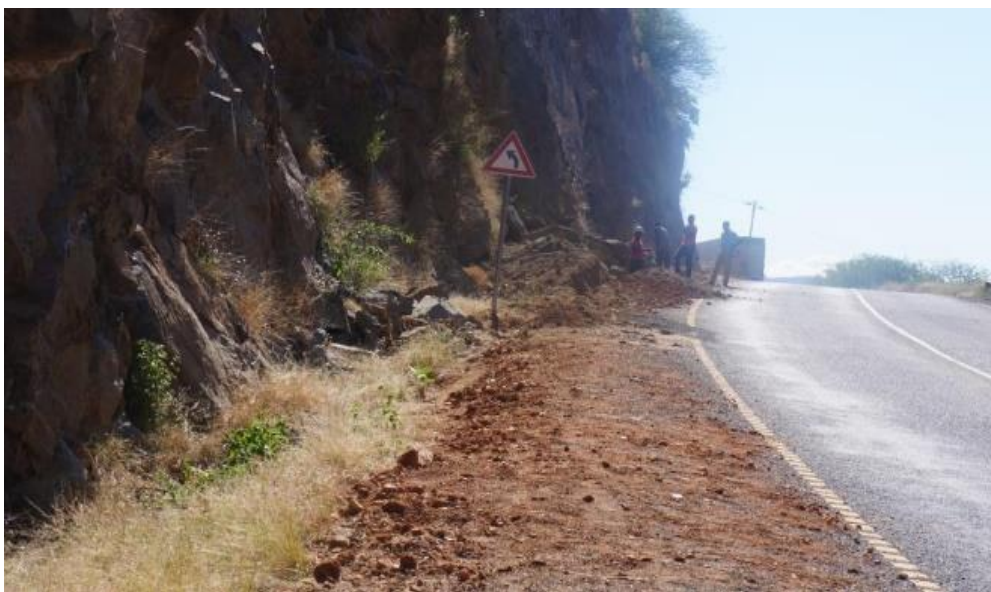
at Nyang'oro area along Dodoma-Iringa road and on sections of Mbeya-Lwanjilo-Chunya road. **Photo 3.9** below shows lack of signs at the stone failing section of the road.

Photo 3.9 Missing warning sign along Iringa-Dodoma road at km 120:200 from Iringa.

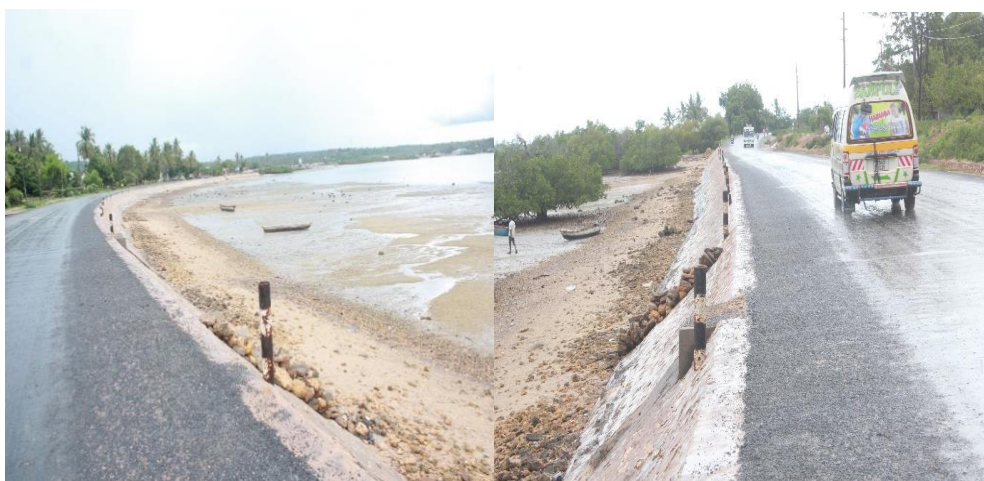
In addition, the audit noted a missing protective guard rail along Lindi-Mtwara at Mikindani area in Mtwara. The road is alongside the shores of Indian Ocean on this area. Although the purpose of guard rails is to alert and show where the road is passing on a dangerous section, they also help to reduce the fatality in case of accident. Presence of guard rails at Mikindani will help the drivers drive cautiously. **Photo 3.10** below shows the missing guard rail at Mikindani area.

Photo 3.10 Missing guard rails along Kilwa road (Lindi-Mtwara) at Mikindani area in Mtwara. Photo taken by auditors on 17-Feb-2017

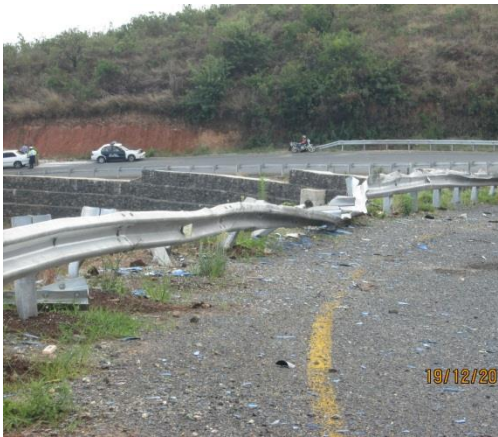
Photo 3.11a: Damaged guard rail along Mbeya-Lwanjilo-Chunya road. Source: Auditors'

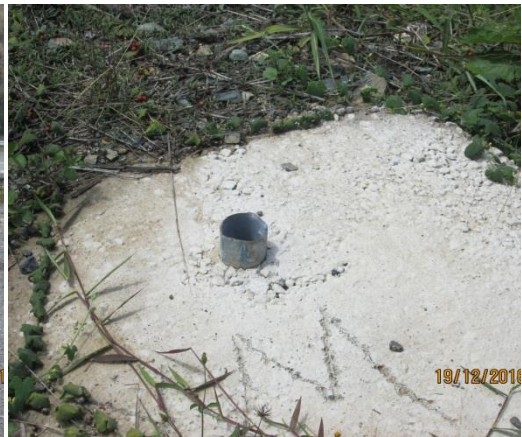
Photo 3.11b: Remaining piece post of stolen road sign along Mbeya-Lwanjilo-Chunya road. Source: Auditors'

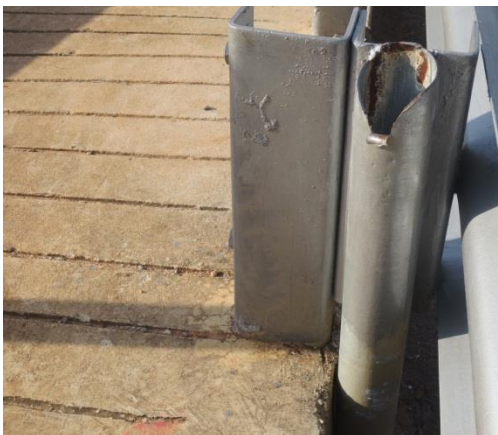
Photo 3.11c: Remaining piece post of stolen bridge chevron sign along Tanga-Horohoro road Ndoyo Bridge. Source: Auditors'

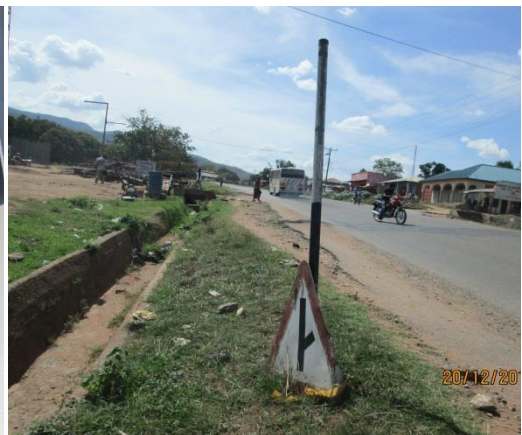
Photo 3.11d: Vandalised road sign (Y-junction) along Mbeya - Iringa road at Chimala Village. Source: Auditors'

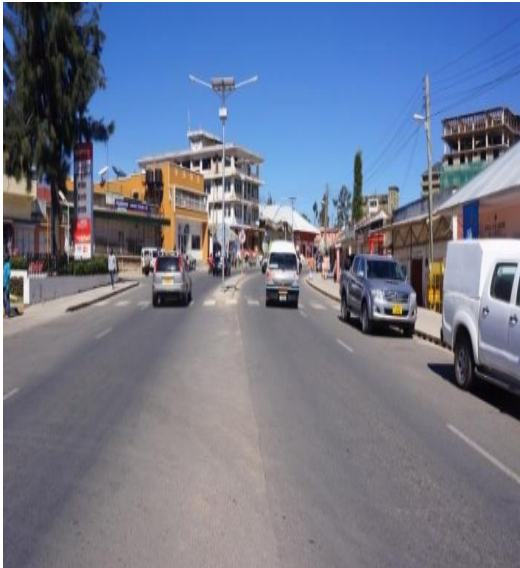
Photo 3.12a: Zebra crossing at the sharp curve along Dodoma-Iringa road

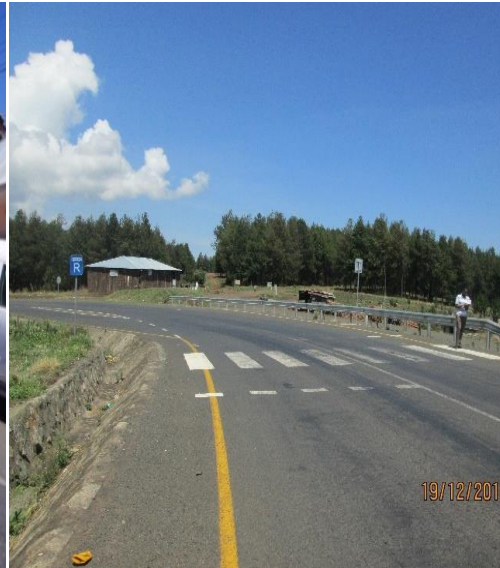
Photo 3.12b: Zebra crossing located at the sharp curve along Mbeya-Lwanjilo-Chunya road

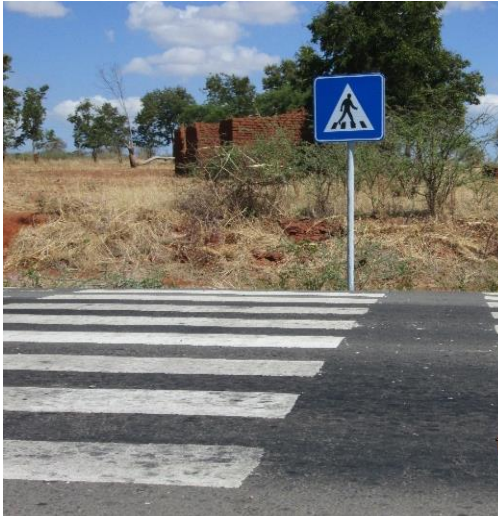
Along Dodoma-Iringa road at Mkungugu village, audit observed the pedestrian crossing signs and humps signs pointing the wrong direction and therefore not serving the intended purpose. **Photos 3.13 a, b and c** below show mis-located roads furniture.

Photo 3.13a: Mislocated Pedestrians sign along Dodoma- Iringa Road at Mkungugu village

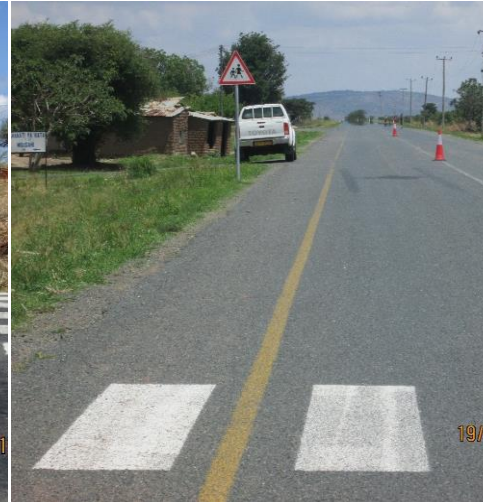
Photo 3.13b: Warning sign erected ahead of zebra crossing along Mbeya-Lwanjilo-Chunya road near Mbugani Zahanati

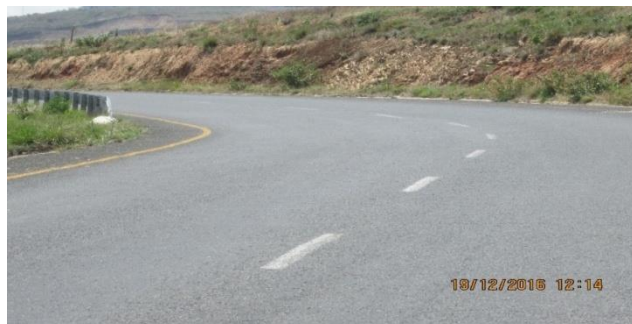
Photo 3.13c: Roads marking allowed overtaking in a sharp curve along Mbeya-Lwanjilo-Chunya road.

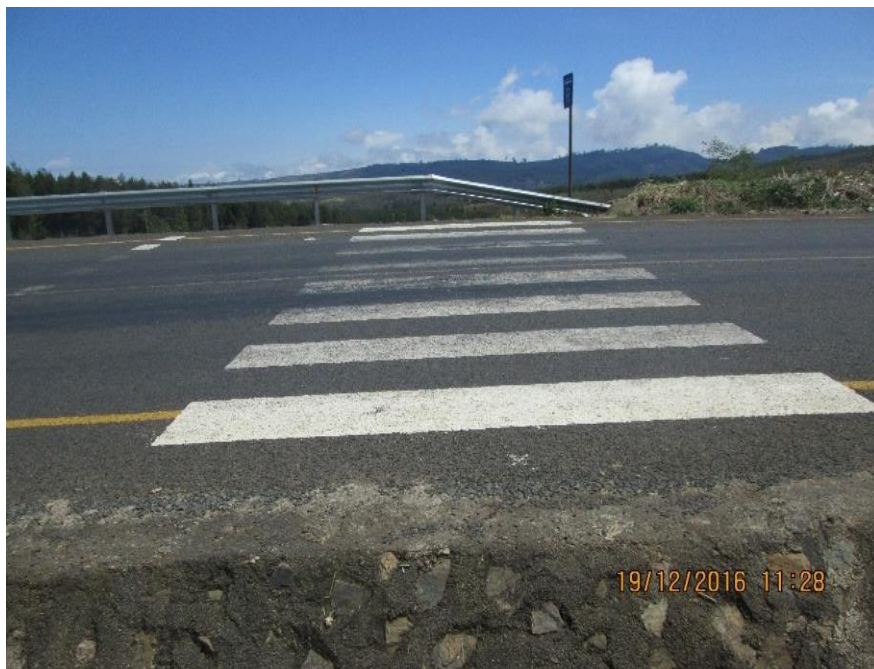
Further to that, the audit observed obstructed zebra crossings. This was more common along Mbeya -Lwanjilo-Chunya. Also, zebra crossing ending in the ditch or guard rails without the provision of pedestrian slabs to facilitate pedestrians to cross off the shoulder. This encourages pedestrians to cross at the shortest direct route and put them at risk of falling in the ditch, knocking themselves on the guard rails or being hit by

Photo 3.14: Obstructed Zebra Crossing Captured by auditors along Mbeya-Lwanjilo-Chunya road

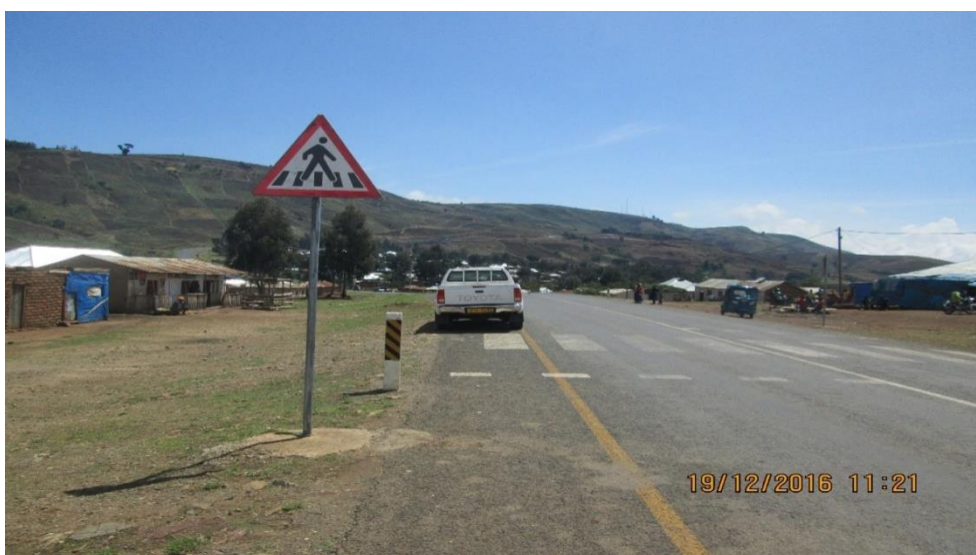
The standard requires that, warning signs be placed at about 60m before a certain feature. However, contrary to that the audit observed short distances from the warning signs to the features such as humps, zebra crossing, curve, bridge or junction. For example, along Mbeya-Lwanjilo-Chunya Road the audit team observed a pedestrian crossing warning sign installed very close to the zebra crossing. The short distance⁹ did not give drivers enough perception time to respond to the sign thus posing a risk of accident. **Photo 3.15** shows one of warning signs installed very close to a zebra crossing.

Photo 3.15: Warning signs erected very close to a zebra crossing along Mbeya - Lwanjilo - Chunya road.

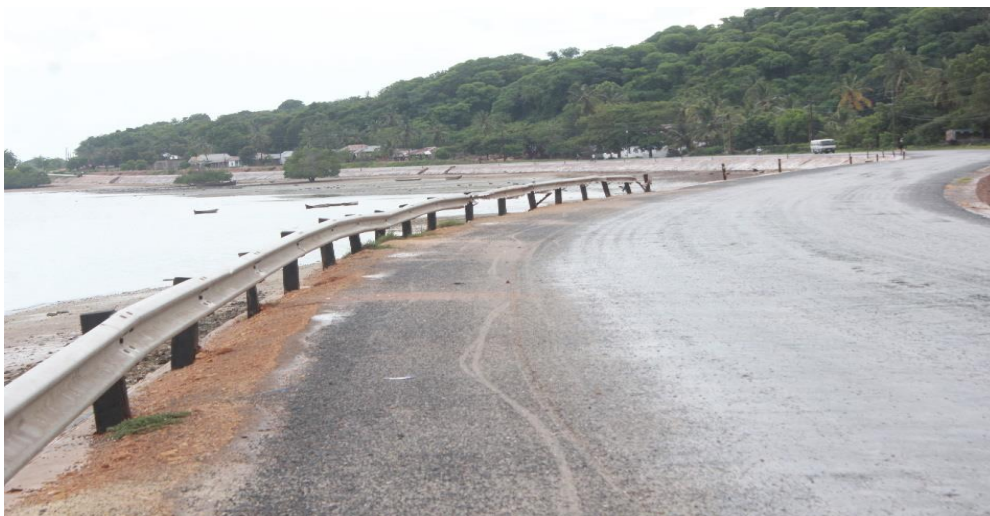
From the **Table 3.7** above, Kilwa (Lindi-Mtwara) road, Mbeya -Lwanjilo-Chunya and Dodoma-Iringa roads were found to have large needs for maintenance of roads furniture. Those needs include replacement and repair of road signs and guard rails. Most of the guard rails have been damaged. Along Lindi-Mtwara road at Mikindani area the audit observed about 2 km long of guardrails severely corroded and some parts of it completely removed as shown in **Photo 3:17**.

Photo 3.1 7: Corroded guardrail with parts missing at Mikindani area as captured by auditors

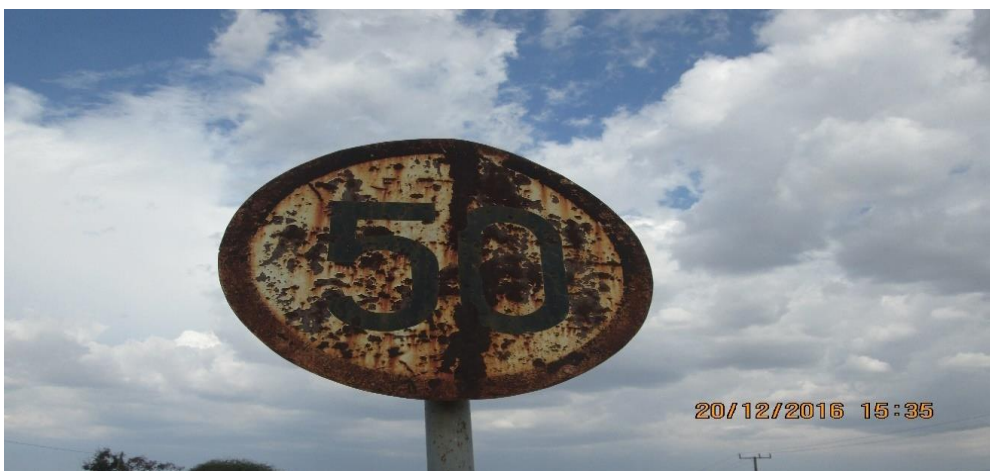
Further, the audit also noted several corroded roads furniture along Iringa-Mbeya (Igawa-Mbeya section). In other roads, condition of roads furniture in terms of corrosion was moderate. **Photo 3:18** below is an example of corroded road sign.

Photo 3.18: Corroded road sign captured by auditors at Chimala village as captured by auditors on 20/12/2016

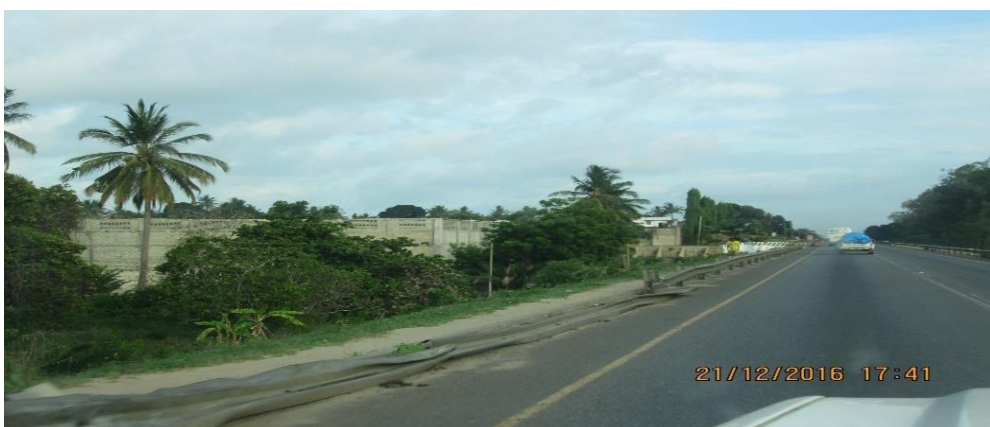
The audit further noted that, TANROADS was not assessing the risks of increased road accidents due to damaged roads furniture. **Photo 3.19** shows damaged guard rail along Dar es salaam-Chalinze road.

Photo3.19: Unattended damaged guard rail along Dar es Salaam - Chalinze road as captured by auditors on 21.12.2016

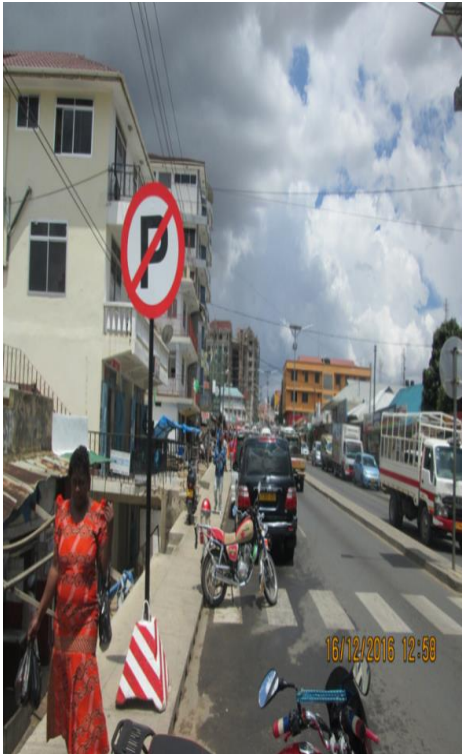
For example, in Iringa town TANROADS installed parking prohibition signs but the Municipal council has continued to allow parking of vehicles on the prohibited section and collect parking fees. **Photo 3.20 (a and b)**; Shows the conflicting of the message between prohibition of parking and presence of legally allowed parked vehicles on carriageway.

Photo 3.20b: Allowed parked vehicle on the prohibited parking sign. Photo taken by auditors in Iringa town on 16.12.2016
