THE UNITED REPUBLIC OF TANZANIA NATIONAL AUDIT OFFICE

PERFORMANCE AUDIT REPORT ON THE MANAGEMENT OF FERRY OPERATIONS

CONTROLLER AND AUDITOR GENERAL
MARCH 2025

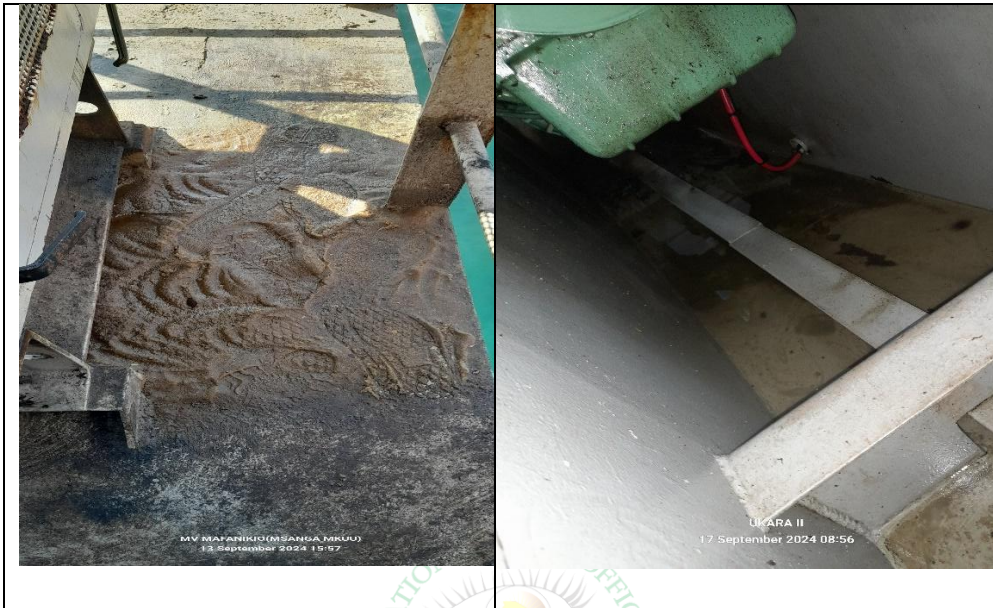
Inadequate inspections of the ferries led to unresolved maintenance issues, including oil leakage on engines, as seen in MV Kazi, MV Mafanikio and MV Ukara II, and unaddressed corrosion on hull structures. Furthermore, TEMESA had insufficient tools and workshops for ferry maintenance. Only one (1) out of six (6) sampled ferry stations, the Magogoni ferry station, had a maintenance workshop. Although Kigongo Busisi had a workshop, it was recently repurposed as the zonal office. Other ferry stations did not have workshops. The available tools were also not sufficient, due to the lack of a comprehensive needs assessment for maintenance tool requirements.

Photo 3. 1: Leakage of the Oil on the Engines

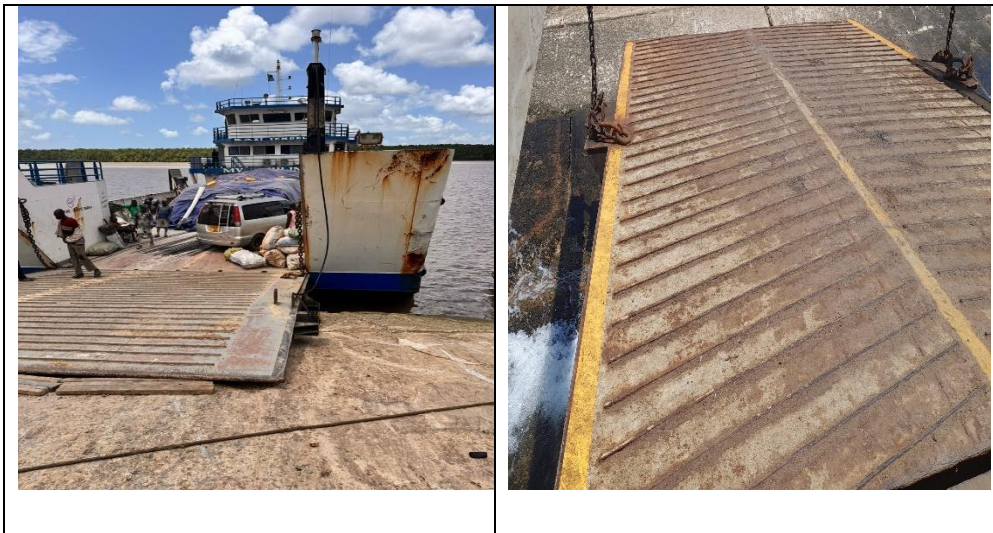
Furthermore, during a site visit, the corrosion on the hull structure was noted in all seven (7) sampled operating ferries, and only MV Mafaniko reported the condition of the ferry in the daily report, referred to in **Photo 3.2**.

Photo 3. 2: Corrosion on the Hull Structure and Ramps

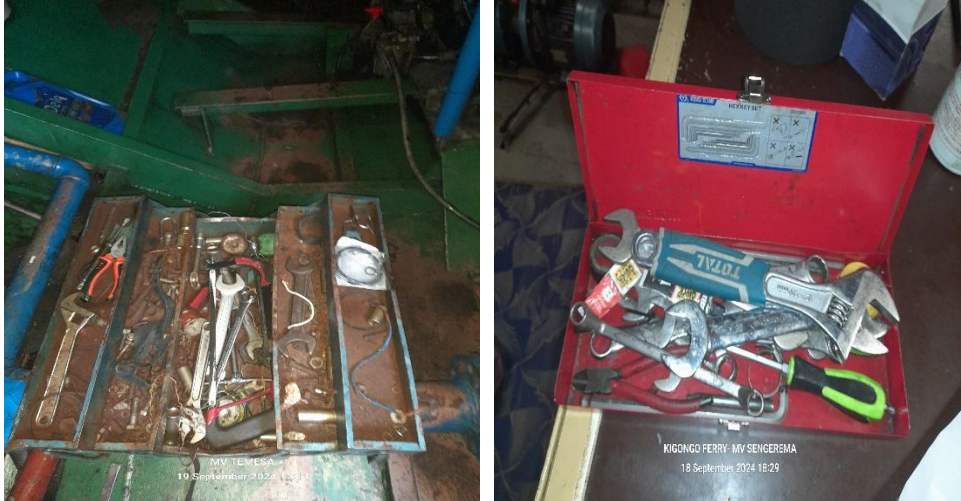
In addition to the lack of tools at the workshops and ferry stations, the audit found that two (2) out of the seven (7) operating ferries, MV Kazi and MV Mwanza, did not have toolboxes at the time of this audit on October 2024. Moreover, three (3) of the five (5) ferries equipped with toolboxes were MV Mafanikio, MV Ukara II, and MV TEMESA, however they had toolboxes with insufficient tools for maintenance. The missing or inadequate tools included incomplete combination spanners, broken spanners, and insufficient box spanners and screwdrivers, as depicted in **Photo 3.3**.

Photo 3.3: Mechanical Toolbox with Insufficient Maintenance Tools (September 2024)

Furthermore, the audit noted that the inadequacy of ferries maintenance tool was due to the fact that in contracts for the rehabilitation and construction of ferries, TEMESA did not include detailed specifications requirements for the toolboxes (such as size and contents) relative to the capacity of the ferries, leaving the contractor to decide on the specifications. The absence of workshops for ferry maintenance, coupled with limited tools, lowers the effectiveness and efficiency of maintenance tasks.

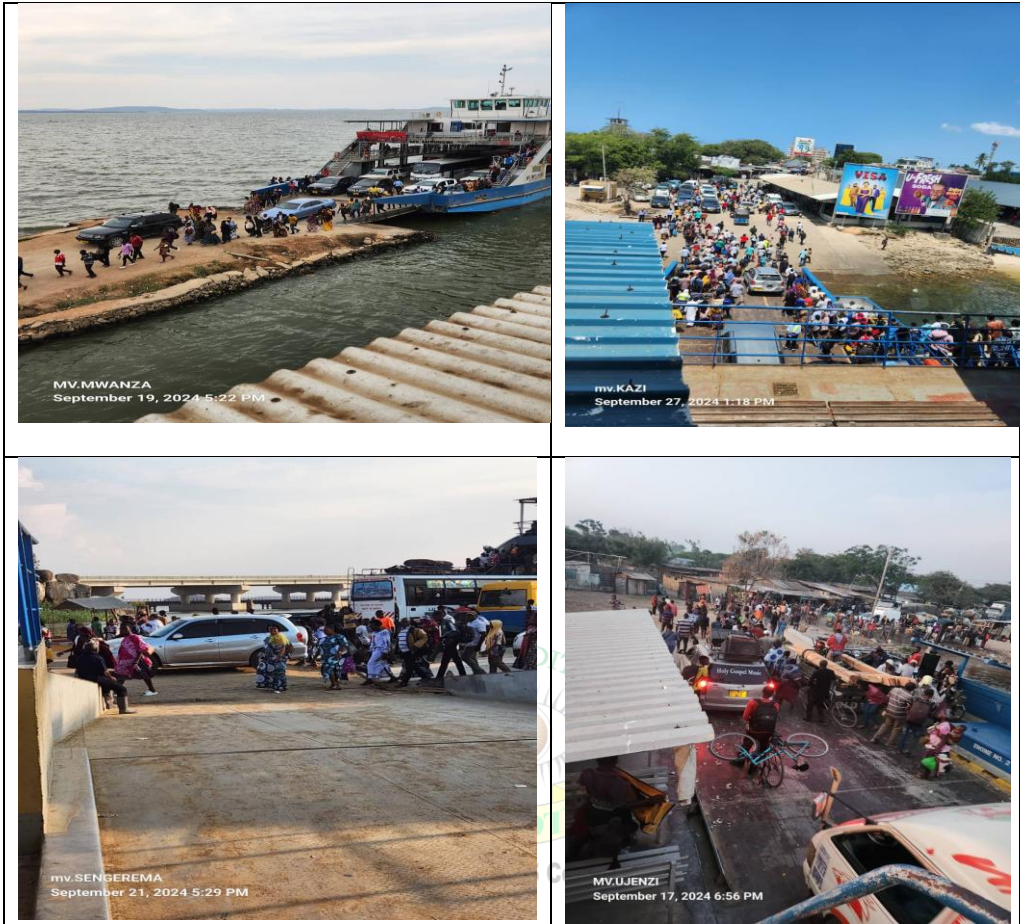
Table 3.24 shows the status of compliance in managing passenger flows. It was observed that disembarking was a challenge to all the visited ferry stations as there was a lack of an efficient ticketing system, and the processes for boarding and disembarking often failed to follow established guidelines at Msanga Mkuu and the sampled Lake and Western Zone Ferry Stations.

This led to overcrowding, safety risks, and delays, underscoring the need for improved operational standards and enforcement of regulations. The images below illustrate how various ferry stations managed the disembarking process.

Photo 3.4: Passengers Flow during Disembarking from the Ferry

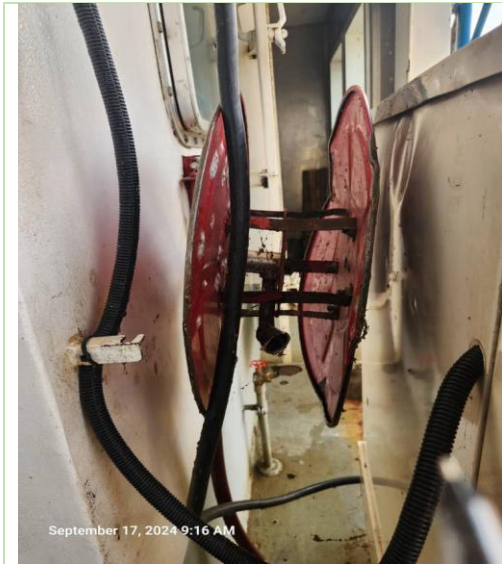
Moreover, the audit found an empty fire bucket at MV Mwanza and MV Kilindoni. As indicated in **Photo 3.5**, the firefighting conditions were not conducive to meeting its functionality during the fire incident. **Photo 3.5 (a), (b), (c) and (d)** show challenges with the firefighting system in the respective ferries.

Photo 3.5(a): Horse rail fitting without horse pipe and nozzle at MV Ukara II

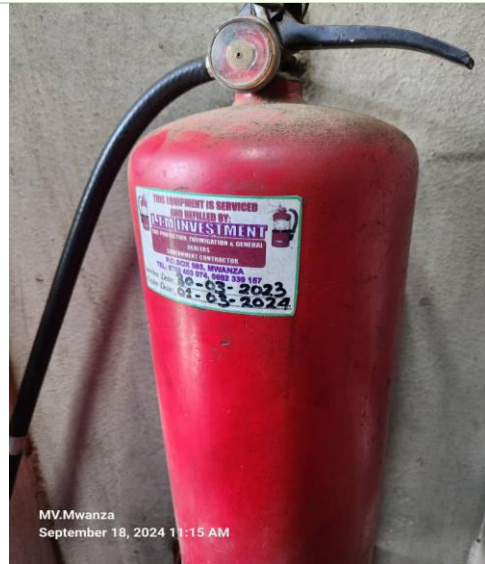
Photo 3.5(b): Expired Portable fire extinguisher as observed in MV Mwanza

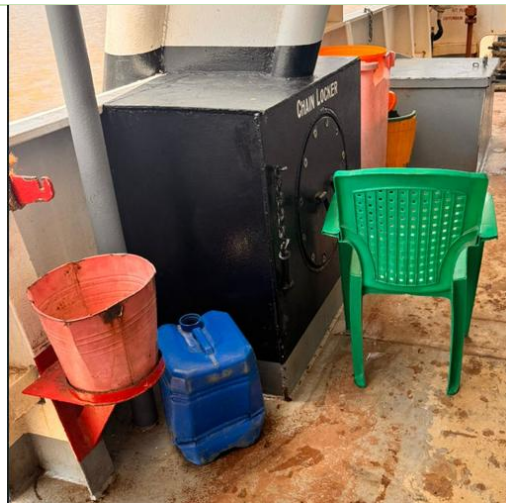
Photo 3.5(c): Fire bucket without dry sand as observed in MV Kilindoni on 17 September 2024.

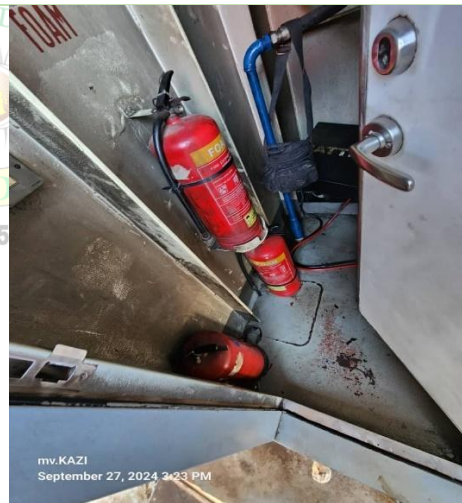
Photo3.5(d): Portable fire extinguisher placed in an inappropriate location at MV Kazi

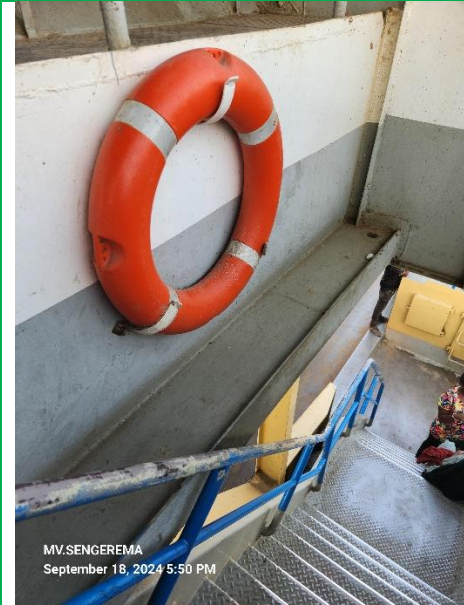
Moreover, apart from the compliance indicated in **Table 3.36**, the audit revealed that all visited ferries' safety appliances were not kept in proper operational state and were not being checked up for their operational state. These were evidenced by the observed life buoy without lifelines to all visited ferries. **Photo 3. 5(a)** and **(b)** show problems with the installed buoy.

Photo 3.6 (a) Life bouy without grap rope and lifeline

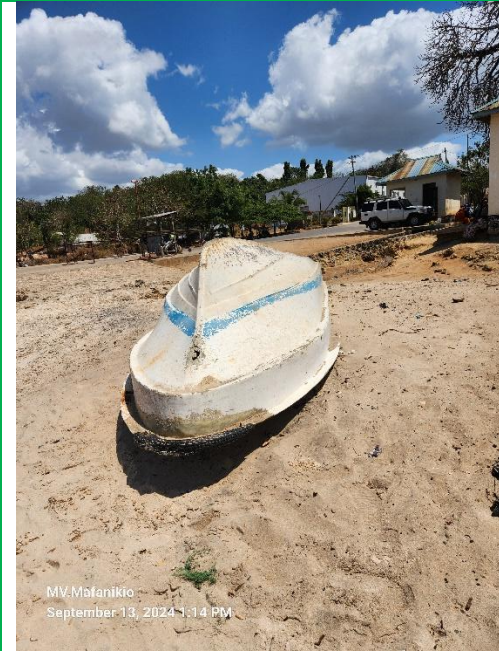
Additionally, the audit observed the presence of rescue boats and life rafts without propelled engines or pedals as observed at MV Mwanza, MV Mafanikio, MV Kazi and MV Ukara II as indicated in **Photos 3.7 (a) and (b)**.

Photo 3.7 (a) Halted Rescue boat at Luchele Ferries station Mtwara.

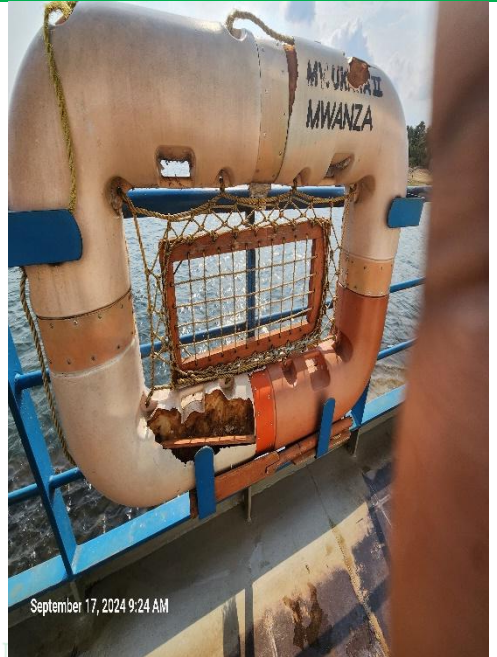
Photo 3.7 (b) Defective Life raft with rotten peddles at MV Mwanza.

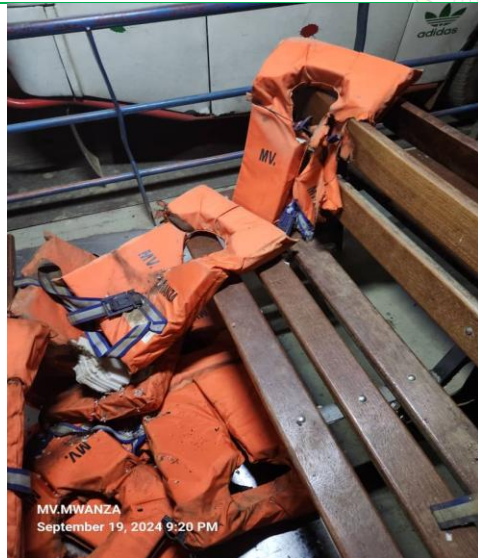
Photo 3.7(c) Defective Life jacket equipped on MV Mwanza.

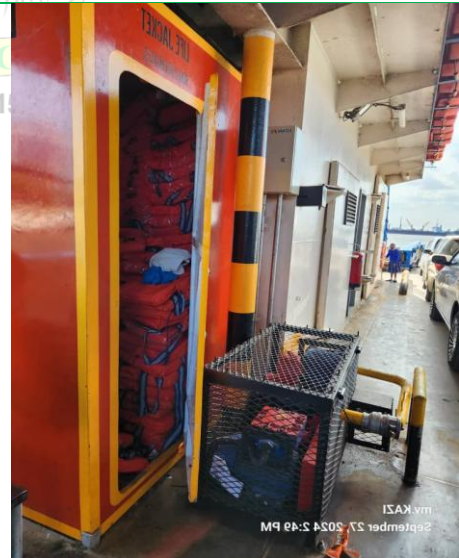
Photo 3.7(d), Fuel system obscured life jacket cage on MV Kazi

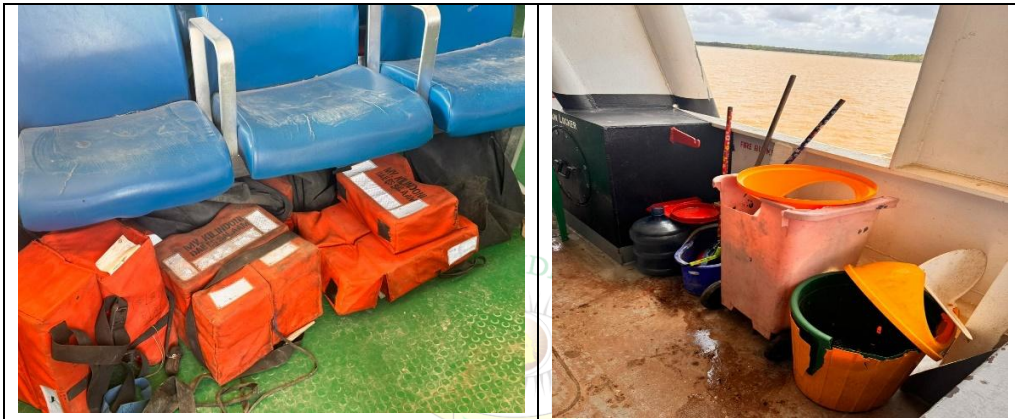
Table 3.44 shows how quality metrics were not adhered to in the ferry operations, with cleanliness emerging as the most neglected area. Across all the visited ferries, cleanliness standards were found to be particularly poor. The worst-case scenario of non-observance of all criteria was evidenced at Nyamisati Ferry Station. Other metrics, such as punctuality and customer service, also showed inconsistencies, but cleanliness was consistently identified as the most critical issue. Lack of regular cleaning schedules, poor waste management, and poor hygiene practices were common problems observed across ferries, as shown in the pictures below.

Photo 3.5 shows the Status of Cleanliness inside MV Kilindoni Ferry.

The Audit noted that no contractor was in place to ensure cleanliness at MV Kilindoni. The contract had been terminated in January 2023, and no contractor had been secured until October 2024. The absence of permanent employees or contractors for cleanliness resulted in the poor cleanliness of the ferry. The ferry managers employed temporary staff who did not have scheduled time to clean the ferries.

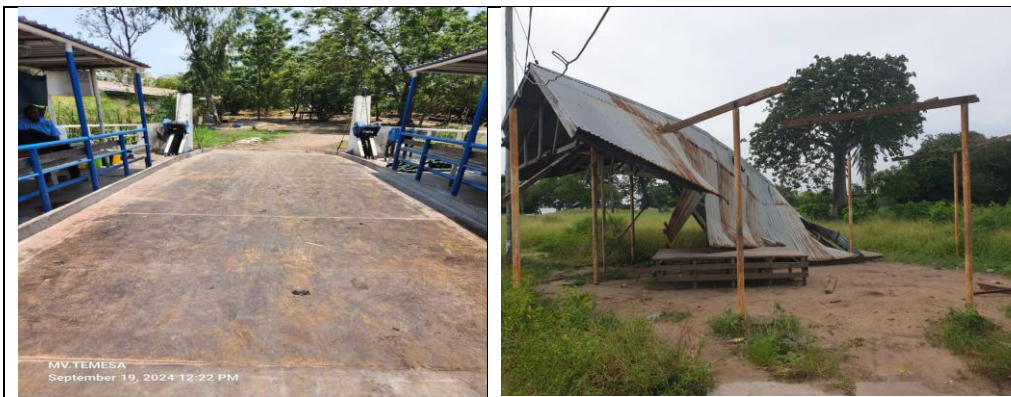
Furthermore, it was noted that four (4) out of six (6) ferry stations had no waiting lounges, so passengers had to wait to board the ferry while under the trees, as revealed in **Photo 3.6** below.

Photo 3. 6 shows the Status of the Waiting Lounges at Luchelele and Msanga Mkuu Ferry Stations.
