**THE UNITED REPUBLIC OF
TANZANIA
NATIONAL AUDIT OFFICE**

**PERFORMANCE AUDIT REPORT ON THE QUALITY OF EXECUTED
BITUMEN SURFACED ROAD WORKS IN URBAN AREAS**

**AS PERFORMED BY THE TANZANIA RURAL AND URBAN ROADS
AGENCY (TARURA) UNDER THE PRESIDENT'S OFFICE -
REGIONAL ADMINISTRATION AND LOCAL GOVERNMENT**

MARCH, 2020

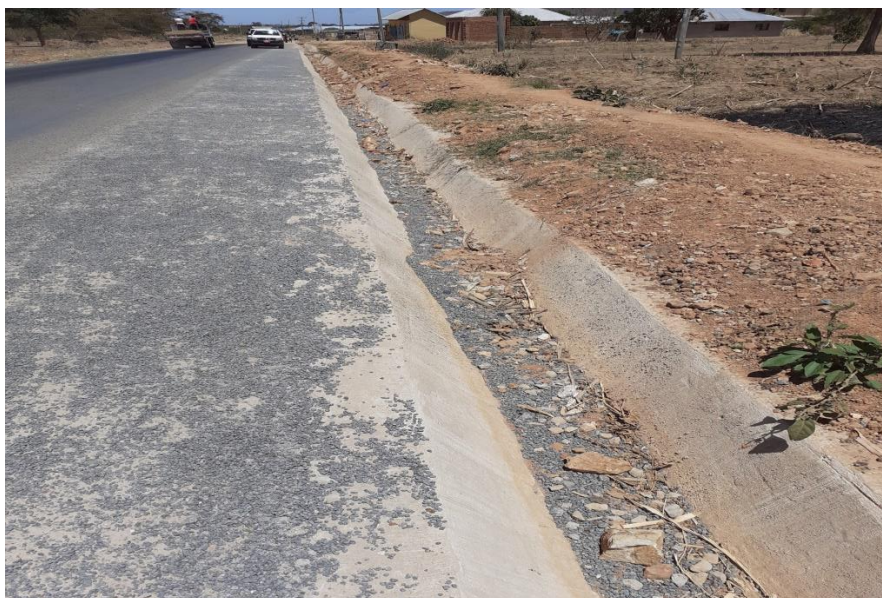
Based on the reviews of correspondence files of different road projects from the visited LGAs, the client involvement in the daily project supervision particularly on road (TARURA) projects which did not involve consultants was very minimal even in the critical stages of the road works execution. There was little supervision in the laying of critical roads layers including sub-base, G15, G7, CRR and C1 layers⁶. Most of the correspondences and reports were noted during the time of testing where contractors were supposed to submit test results for the executed works. Photo 1 shows chipping strip off as one of the types of defects observed in one of the roads that were visited in Iringa region.

Photo 1: Chipping strip-off as one of the defects along Don-Bosco Mawelewele Road in Iringa MC.

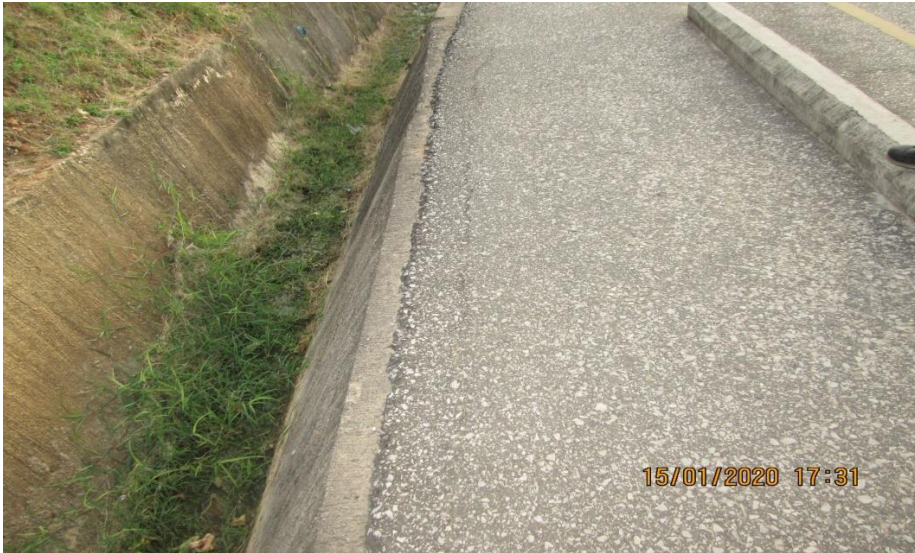
This implies 82% and 84% of 38 visited road projects had no quality assurance plans and quality control plans respectively. The quality of executed paved roads was insufficiently controlled by project supervisors as a result, executed roads had inadequate quality. This was observed during the site visit whereby the audit team witnessed the use of wrong construction materials as aggregates for CRR and Asphalt Concrete layer as shown in Photo 2 below.

Photo 2: Coral limestone aggregates used for wearing course mined from the wrong sources as per original design. (Photo taken by auditors on 15th January 2020)

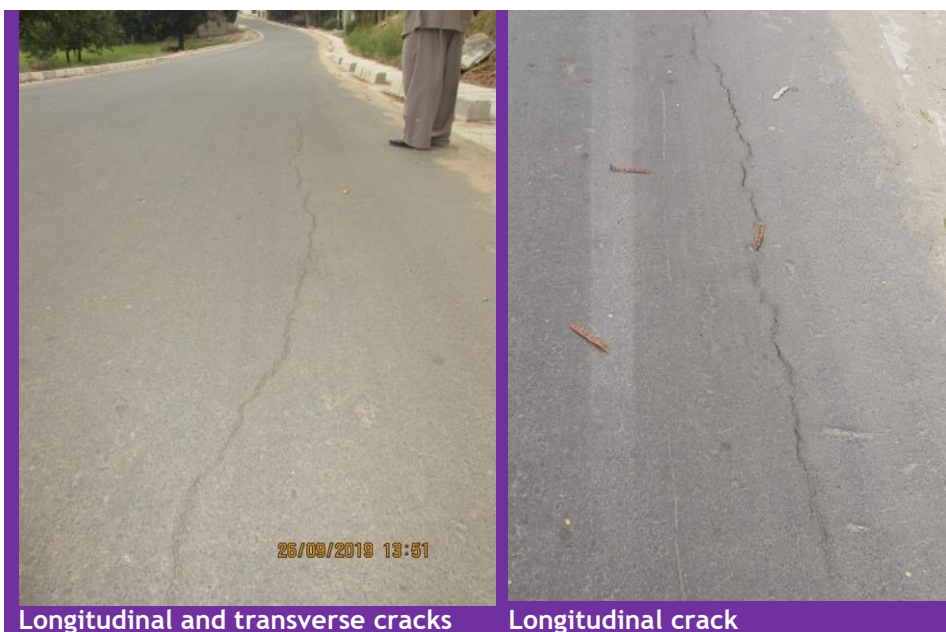
For instance, through the site visits that were conducted the audit found out visible and physical extensive longitudinal and transverse cracks and bleeding for completed *Changanyikeni to Shuleni road in Kinondoni Municipal Council (as seen in photo 3 below)*, whereby the road is still under Defect Liability Period. It was expected that if the road project had regularly supervised it could have been free from these extensive defects. This was due to lack of Quality Assurance and Quality Control Plan set prior to the commencement of the road project.

Furthermore, interviews held with TARURA officials from Kinondoni Municipal Council confirmed that, supervision had not been effectively done due to inadequate number of engineers responsible for inspection and supervision of road projects that were underway.

Photo 3: Longitudinal and transverse cracks observed along Changanyikeni-Shule Road (Photo taken by auditors on 26th Sept 2019)

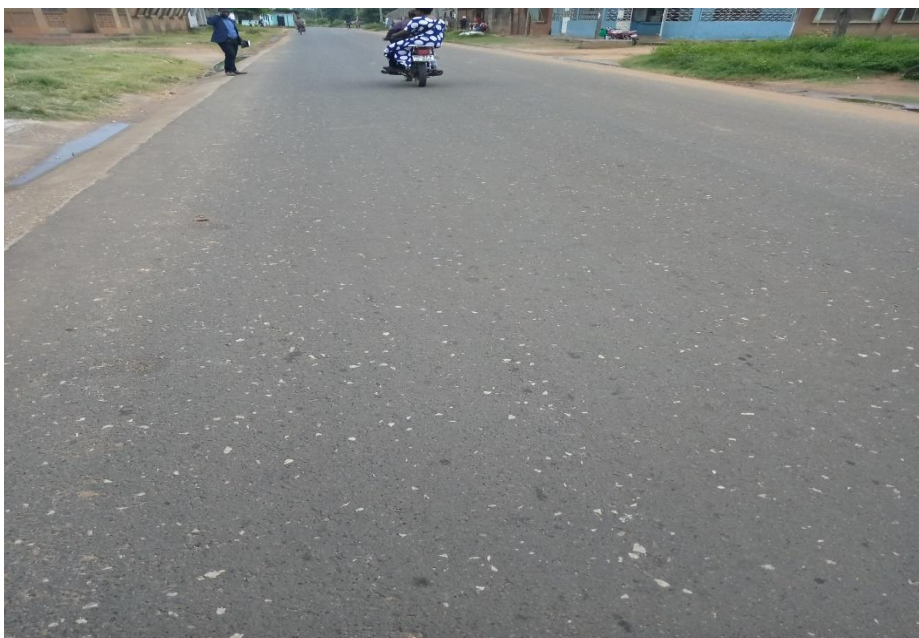
Consequently, improperly closed road projects left the road surface with unclosed defects and prone to additional damages and therefore reducing the lifecycle of the constructed roads. Additionally, road works without proper features brings a huge risk to the safety of pedestrians and other road users. Photo 4 below shows one of the road projects completed and handed over without road marking and road signs at Tanga CC.

Photo 4: Sahare road without road marks and signs captured in Tanga CC by Auditors on 16th January 2020
