PERFORMANCE AUDIT REPORT ON THE MANAGEMENT OF WATER PROJECTS IN RURAL AREAS

**A REPORT OF THE CONTROLLER AND AUDITOR GENERAL OF THE UNITED
REPUBLIC OF TANZANIA**

March, 2019

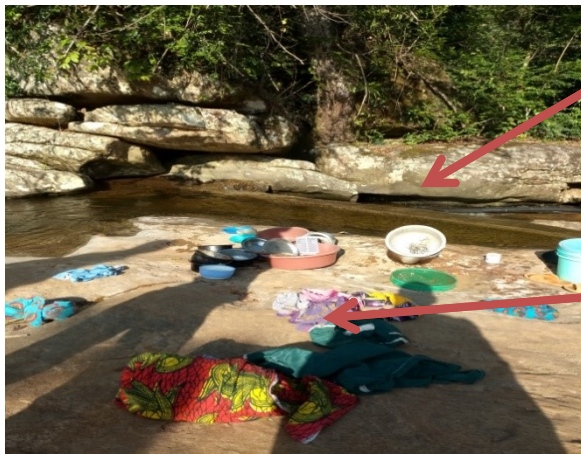
Photo 3.1

Through site visits at Kigugu water projects in Mvomero DC, the audit team found out those members of the community who were washing their clothes exactly at the intake point. The health of the community who were using such water sources were at risk to epidemic diseases like cholera due to pollution of water at the intake point. **Photo 3.1** hereunder shows the activities which were going-on at the intake of Kigugu water project.

Water intake at
Kigugu water
project

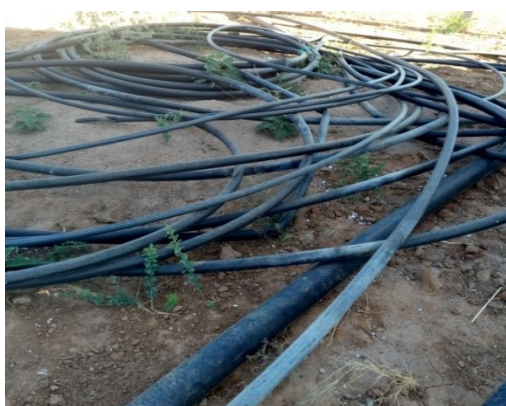
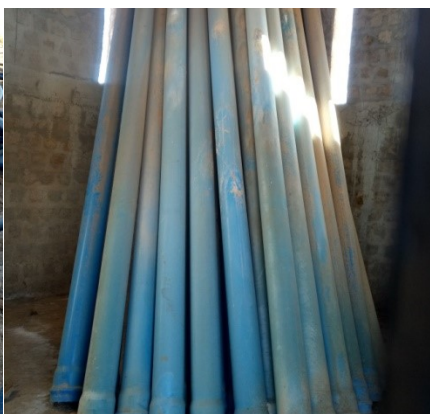
Photo 3.2 (a) and (b): Show remained pipes at Londoni water projects in Manyoni DC

Furthermore, neither the accompanied district water engineer nor secretary of COWSOs were able to tell the exact number of excess water pipes available until when they were counted with the audit team. This poses the risk of loss of some of the water pipes. The projects completed in 2014 and no one was monitoring the remaining pipes. Photo 3.2 shows the remained water pipes at Londoni water projects.

Source: Londoni water project in Manyoni DC

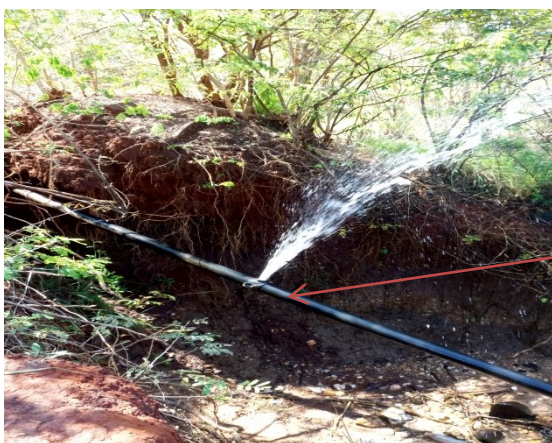
Photo 3.3: Mlali Kipera water project (Photo was taken on 29/11/2018)

Moreover, during site visits, it was noted at Mlali-Kipera water projects in Mvomero DC that the pipe which was supplying water from intake to water tank had leakages whereby a lot of water were lost. Photo 3.3 shows main water pipes.

Water leaking from
main water pipe
from intake at Mlali
Kipera water project
in Mvomero DC
