THE UNITED REPUBLIC OF TANZANIA NATIONAL AUDIT OFFICE

PERFORMANCE AUDIT REPORT ON OPERATION AND MAINTENANCE OF WATER SUPPLY SCHEMES IN TANZANIA

MARCH 2023

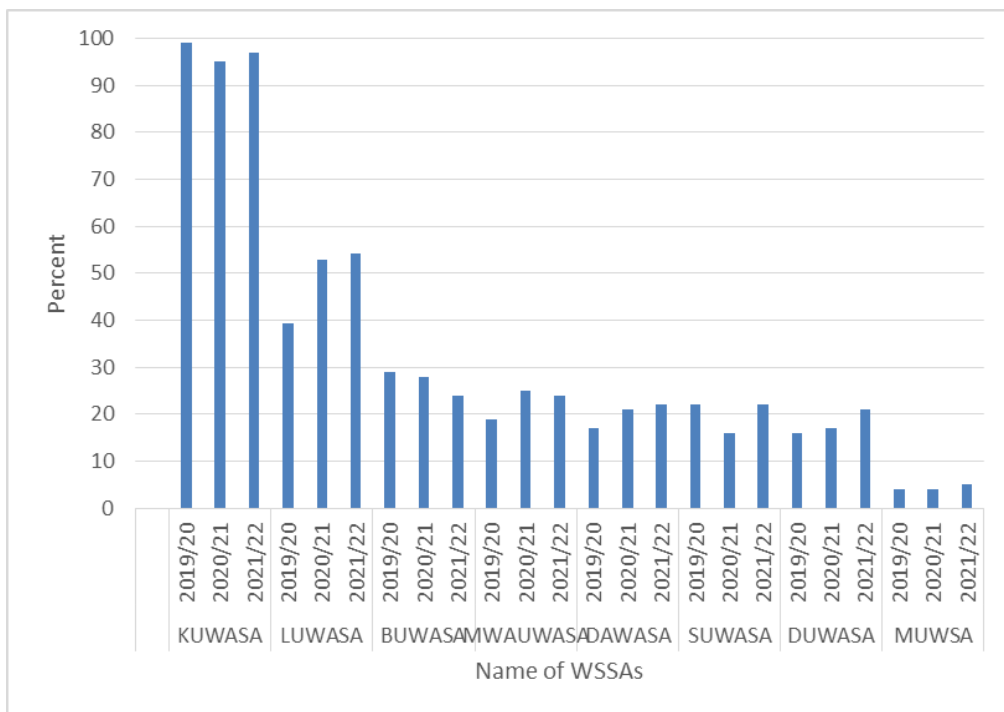
Figure 3.1: The Percentage of O&M budget paid as electricity bills in WSSAs

Figure 3.1 shows that, 2 out of 8 visited WSSAs had more than 50% of the allocated budget for O&M which was used for electricity bills. KUWASA used nearly 100% of O&M in all 3 years to pay for the electricity bills. For the remaining 4 WSSAs, despite showing that the percentage of O&M which were used for electricity bills were below 50%, the money spending was significant as it ranged from TZS 293 to 713 million. For detailed information on the amount of budget for O&M allocated and electricity bill see **Appendix 6**

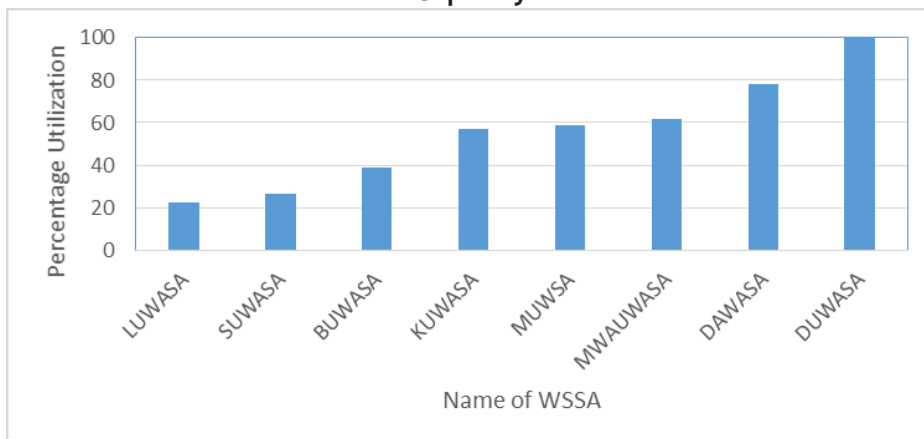
Figure 3.2: The Percentage of Utilisation of Installed Infrastructure Capacity

Figure 3.2 shows that, out of 8 visited WSSAs, only 1 (DUWASA) utilised installed capacity by 100%. DAWASA and MWAUWASA were also noted to have relatively high utilisation of the installed capacities of 78.5% and 61.8% respectively. Moreover, LUWASA was noted to have the lowest utilisation capacity among the visited WSSAs with only 22.6% utilisation capacity.

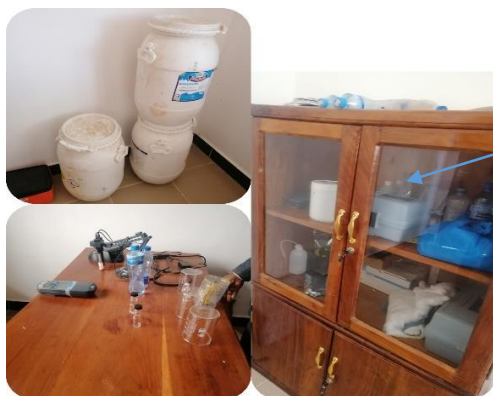
Photo 3.1: Designated room as Laboratory in LUWASA. The Photo was taken by Auditors on 05th February, 2022

During the site visit to water treatment facilities, it was noted that, in 2 out of 8 visited water treatment facilities, there was no daily measurement of water quality parameters before and after treatment. This was observed in Lindi Urban Water Supply and Sanitation Authorities (LUWASA) and Kigoma Urban Water Supply and Sanitation Authority (KUWASA), treated water was inadequately tested but supplied to the community. Moreover, at the time of visit in LUWASA, the responsible officer was on leave for the whole month without replacement of the daily activities of testing the quality of supplied water. Also, the daily water quality control logbook was not presented to Auditors for verification.

Despite LUWASA serving more than 71,241 people in Lindi Region, water treatment facilities for Ng'apa water supply scheme, with investment of more than TZS 33 billion, lacked standard laboratory for daily/frequent testing of water quality as per requirement. **Photo 3.1** shows the room which was used as laboratory without proper organisation that was required for a laboratory.

Designated room and equipment for daily monitoring of water quality at Lindi Urban Water Supply and Sanitation Authority

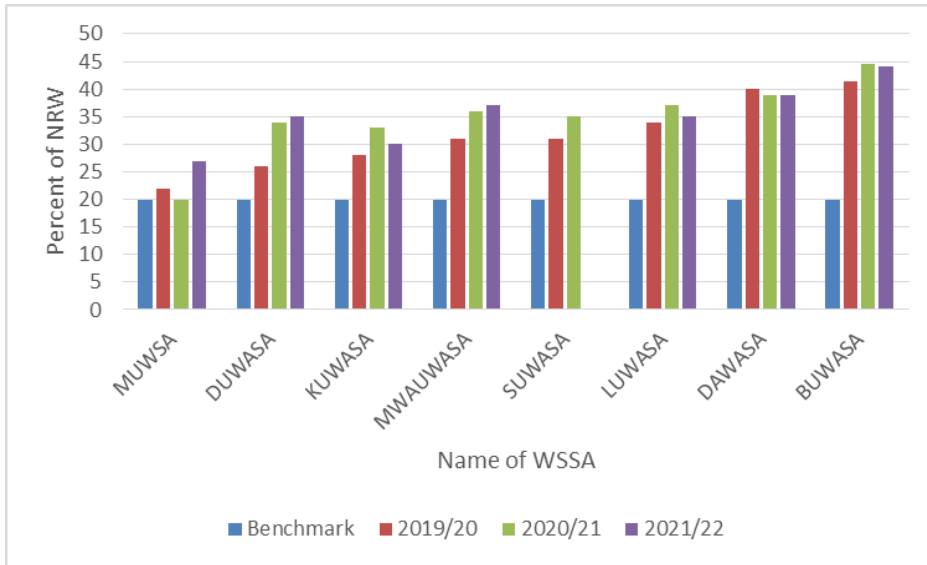
Figure 3.5: The Status of Non-Revenue

Figure 3.5 shows that, for the financial year 2019/20, 2020/21 and 2021/22 out of eight visited WSSAs only 1 WSSA namely Moshi managed to meet recommended level of 20% NRW in 2020/21. The maximum NRW was noted in Bukoba with 42%, 45% and 44% in 2019/20, 2020/21 and 2021/22 respectively. Among the visited 8 WSSAs, Moshi had a satisfactory performance with 22%, 20% and 27% in the year 2019/20, 2020/21 and 2021/22 respectively.

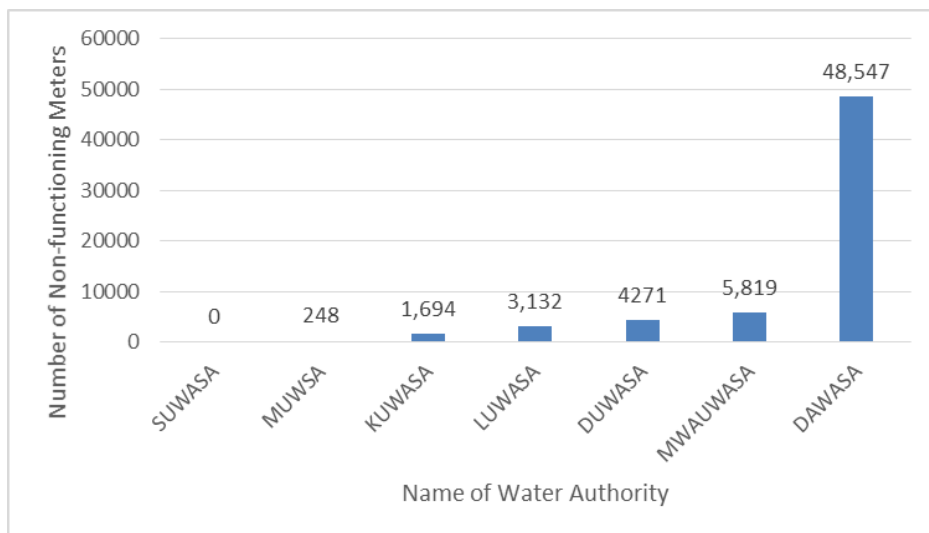
Figure 3.6: The Status of the Non-functioning Water Meters

Figure 3.6 shows that, the maximum number of defective water meters was noted in DAWASA, For instance DAWASA had 48,547 water meters while the minimum was noted in SUWASA with 0 water meters. The figure further shows that, in the visited WSSAs, only SUWASA had no non-working meters.

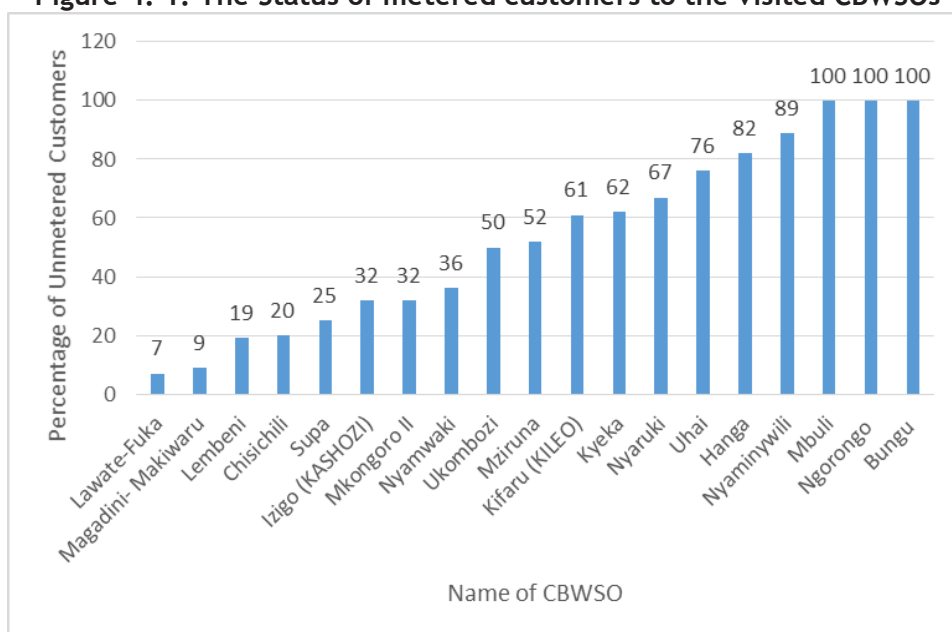
Figure 4. 1: The Status of metered customers to the visited CBWSOs

Figure 4.1 shows that, for the visited 19 CBWSOs, 11 had 50% or more of their customers with no water meter connections while 3 CBWSOs had 100% of their customers who were not metered at all. In addition, the visited CBWSOs were also lacking Bulk meters.
