THE UNITED REPUBLIC OF TANZANIA NATIONAL AUDIT OFFICE

PERFORMANCE AUDIT REPORT ON THE MANAGEMENT OF FERRY OPERATIONS

CONTROLLER AND AUDITOR GENERAL
MARCH 2025

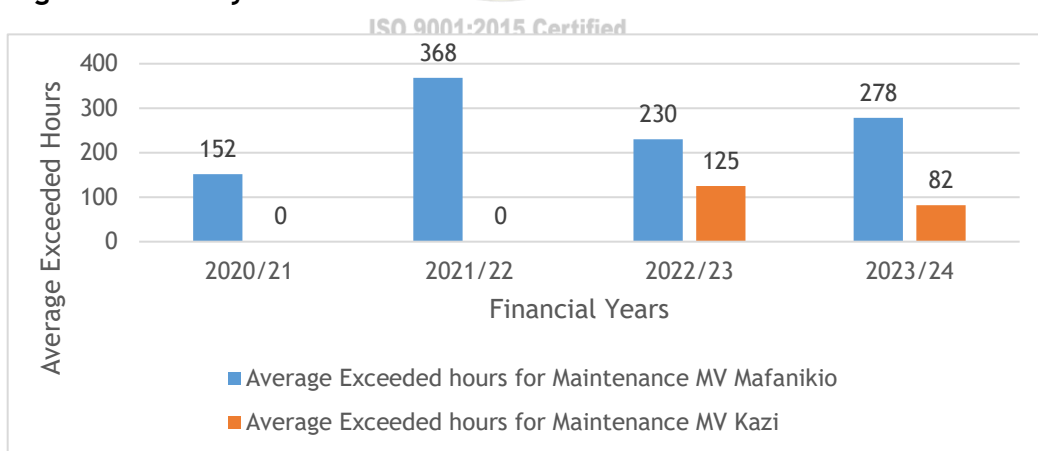
Figure 3.1: Analysis of the Exceeded Hours for Conducted Maintenance

Figure 3.1 shows the average hours exceeded for maintenance of MV Mafanikio and MV Kazi over four financial years. For MV Mafanikio, maintenance performance fluctuated, with exceeded hours increasing from

152 hours in 2020/21 to a peak of 368 hours in 2021/22, the highest in all years. In contrast, for MV Kazi, maintenance hours were not documented for the years 2020/21 and 2021/22; only the dates were recorded (see Figure 3.2). However, in 2022/23, exceeded hours were recorded at 125 hours, followed by a reduction to 82 hours in 2023/24.

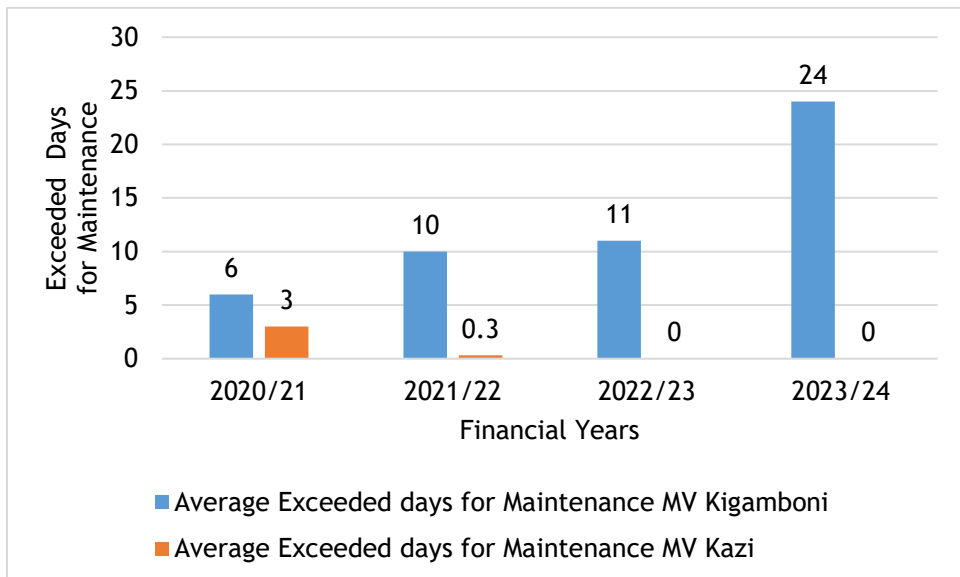
Figure 3.2: Analysis of the Exceeded Days for Conducted Maintenance

Additionally, maintenance hours were not documented for MV Kigamboni; instead, the planned and actual maintenance dates were recorded. There were noted delays in the maintenance dates, leading to exceeding the required maintenance days (see Figure 3.2).

Figure 3.2 shows that MV Kigamboni’s maintenance exceeding days increased over the years, starting at six (6) days in 2020/21, rising to ten (10) days in 2021/22, slightly increasing to eleven (11) days in 2022/23, and peaking at twenty-four (24) days in 2023/24. This consistent upward trend indicates a challenge in maintaining scheduled timelines for MV Kigamboni. In contrast, MV Kazi experienced minimal delays in the initial years, with three (3) exceeding days in 2020/21 and a few hours in 2021/22.

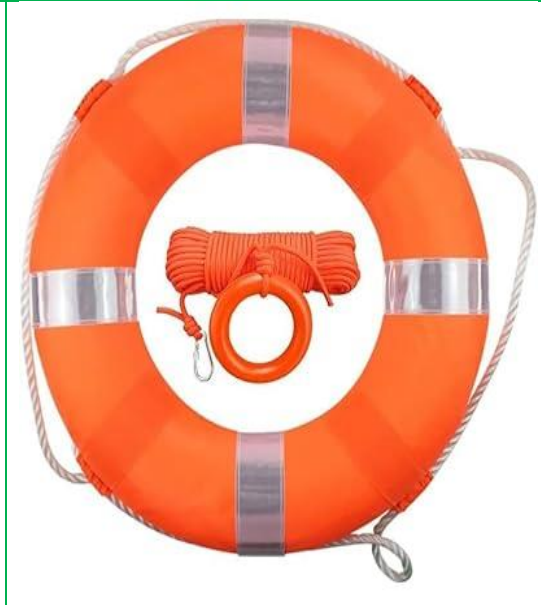
Photo 3.6 (a) Life bouy without grap rope and lifeline

Photo 3.6 (b) Life bouy with grap rope and lifeline

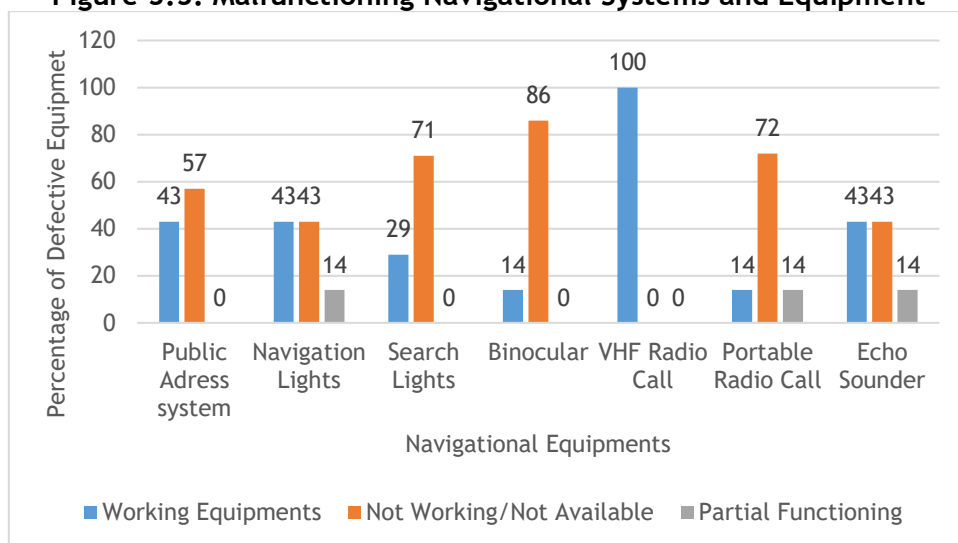
Figure 3.3: Malfunctioning Navigational Systems and Equipment

Verification done on the sampled ferries revealed that they were operated with malfunctioning navigational systems and equipment. Specifically, navigational lights, searchlights, binoculars and communication systems, despite being indicated by the Merchant Shipping (Safety of Navigation) Regulations, 2023, as the carriage requirements for shipborne navigational systems and equipment, as shown in **Figure 3.3**.
