**THE UNITED REPUBLIC OF
TANZANIA
NATIONAL AUDIT OFFICE**

**PERFORMANCE AUDIT REPORT ON THE QUALITY OF EXECUTED
BITUMEN SURFACED ROAD WORKS IN URBAN AREAS**

**AS PERFORMED BY THE TANZANIA RURAL AND URBAN ROADS
AGENCY (TARURA) UNDER THE PRESIDENT'S OFFICE -
REGIONAL ADMINISTRATION AND LOCAL GOVERNMENT**

MARCH, 2020

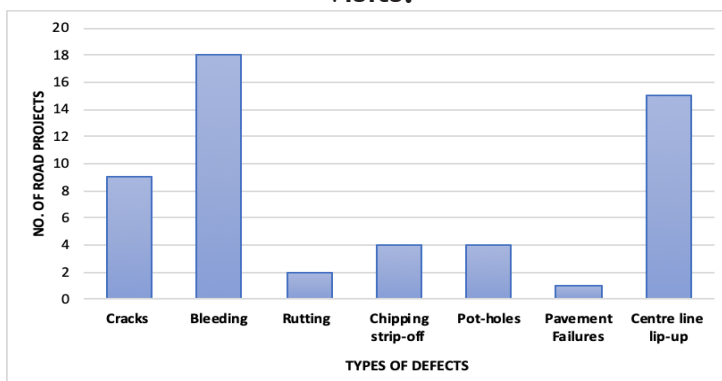
Figure 3.1: Roads Defects/deficiencies observed during site visits.

Figure 3.1 indicates the extent of major defects from the visited roads with bleeding and centre-line lip-up being the most common type of defects. The audit team noted that 30 out of 38 road projects that were completed or were at completion stage had different types of physical defects as depicted by Figure 3.1. The most common types of defects were bitumen bleeding on the road surfaces (refer **Appendix 5**).

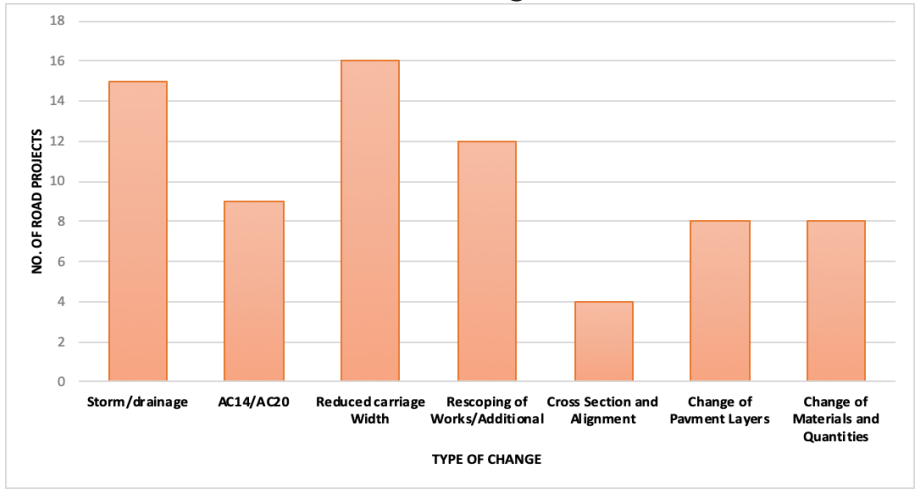
Figure 3.3: Major Design Changes Resulting from Inadequate Road Designs

Figure 3.3 indicates different types of design changes as a result of inadequate road designs. From 12 visited LGAs, 16 out of 38 selected and visited roads have undergone changes due to shortage of road widths. This implies that 42% of bitumen surfaced roads were constructed without considering the originally designed road widths. This happened because the designs were not conducted in respect to physical site conditions.
