PERFORMANCE AUDIT ON MANAGEMENT OF CONSTRUCTION ACTIVITIES ON IRRIGATION PROJECTS

REPORT OF THE CONTROLLER AND AUDITOR GENERAL

MARCH 2019

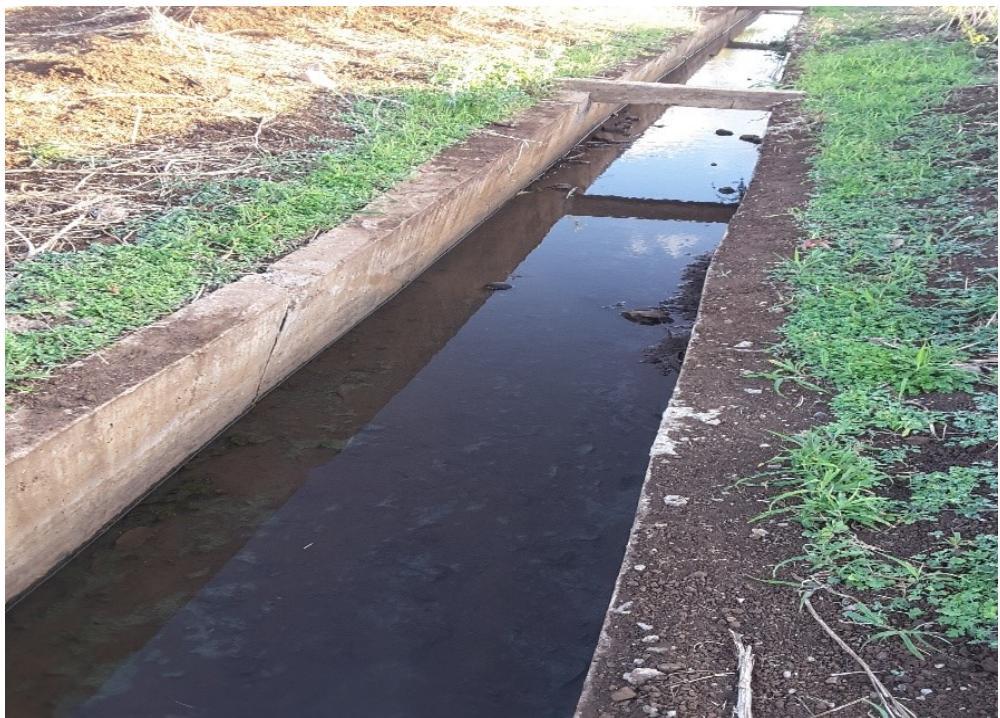
finding that the hard stratum was not found as it had been designed	
	Kiroka	Geotechnical investigation	Emerged sub- surface water which made pillars for aqueduct not to be suitable option, instead cross drainage structures were built for the sustainability of the project during site revision	
Mbeya	Mghambalenga	Geotechnical investigation	Canal route excavated materials changed from normal soil (as in BoQ) to 75% rock actual site condition. Hence canal length was reduced from five (5) Kilometres to one (1) Kilometre	Variation of TZS 42 million
Kilimanjaro	Themi ya simba	Soil Investigation	Presence of black cotton soil at the chainages 319.2m and 1600m. This led to bending of canal wall toward inside (excessive lateral earth	Variation of TZS 11.8 million

pressure) See photo 1	
	Kigongoni	Geotechnical investigation	Presence of hard rock along right of way of the right abutment wall(at the headwork)	Variation of TZS 4.9 million
Mwanza	Buhangaza	Engineering and Preliminary design	The canal changed from 578.3m BoQ length to 590m actual site condition length.	Variation of TZS 26 million
	Kyota	Engineering and Preliminary design	Quantified BRC ¹⁰ weight in BoQ was 847kg for the canal length of 385m, while in actual situation was enough for only canal length of 119.23 m.

Based on **Table 3.9** following deficiency were noted for the seven (7) schemes that were observed to have some defects. Four (4) schemes skipped geotechnical investigation, two(2) schemes skipped detailed design and one(1) scheme skipped soil testing component of feasibility study. In these seven (7) irrigation projects, the most frequently skipped aspects of feasibility studies were geotechnical investigation. During interviews with officers at ZIOs revealed that, cost of conducting geotechnical study was higher than other studies and needed expertise and equipment. The audit observed bending of canal due to impact of black cotton soil. This was among the impacts connected to lack of geotechnical data for this project (Refer Photo 1).

Photo 1: Bending inside of Themi ya Simba canal due to impact of black cotton soil, taken by auditors on 26th November 2018

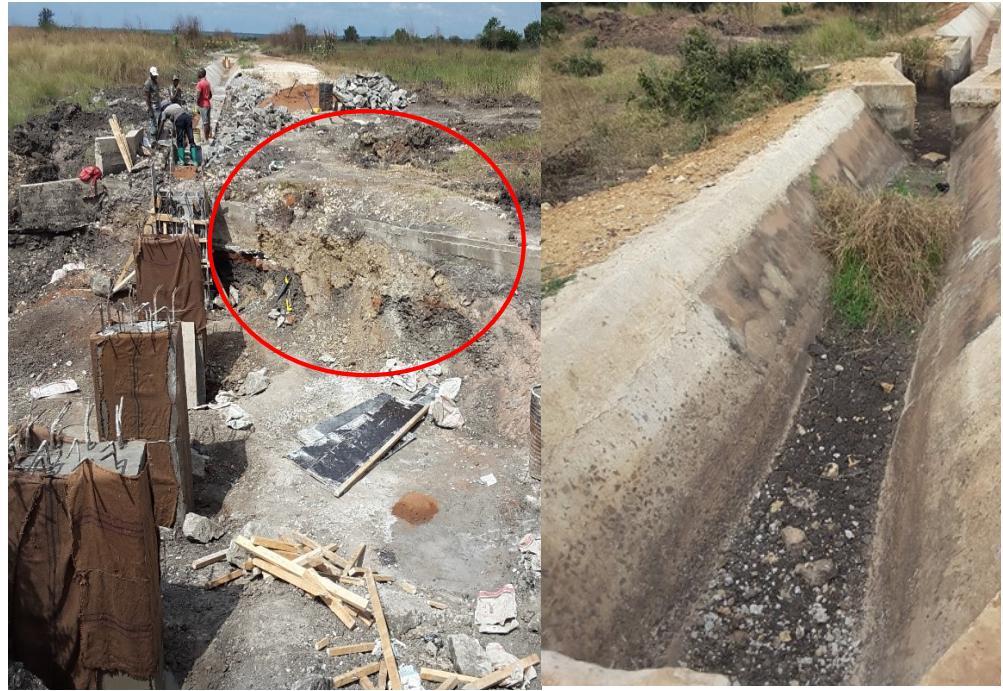
For example, Wami-Luhindo the Irrigation scheme was highly affected with severe rainfall. The culvert and a 10 meter length of a built canal were eroded because of excessive storm. The audit noted that there were no mitigating measures designed to deal with these incidents. In this area, there was uncontrolled farming, grazing and other human activities in the upstream. Because of that, the water stream was widened and therefore the quantity of water that crossed the existing culvert was more than its designed capacity. **Photo 2** depicts the destructed culvert. This destruction added cost of repairing and increased more risk of further destruction.

Photo 2: Destructed culvert (Circled red) and construction activities of new structure of aqueduct at Wami-Luhindo Irrigation Scheme as it was taken by Auditors on 12th July 2018

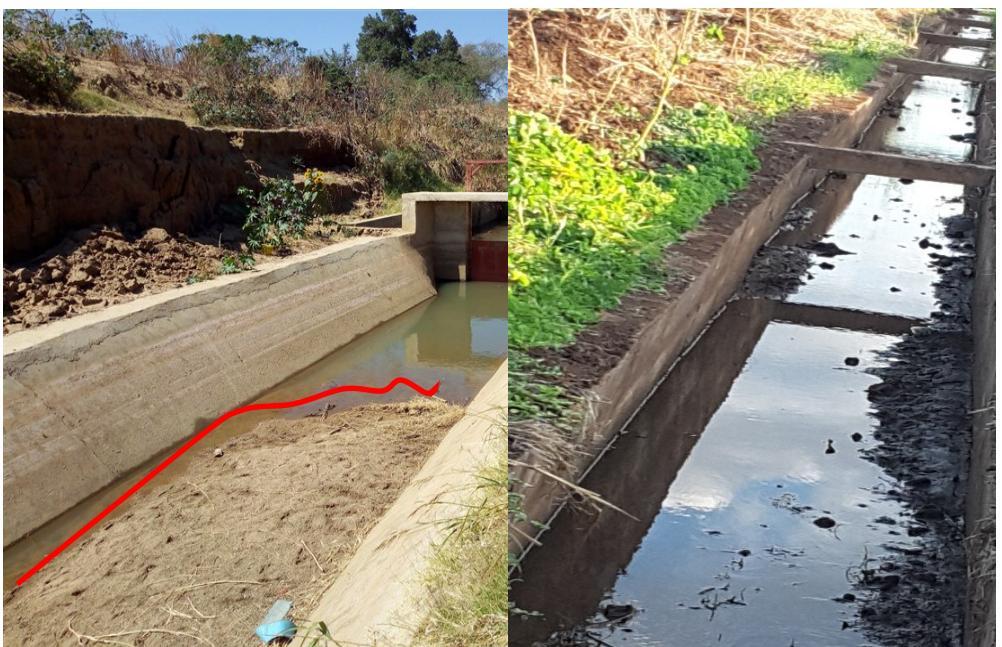
In addition to that, the audit noted the siltation condition at Mwenda-Mtitu and Themi ya Simba irrigation schemes (Refer **Photo 3a and 3b**). The siltation caused reduction of the depth of canal (reduced canal discharge capacity). Because of this, there was an overflow of the discharged water, which led to loss of water before reaching the farms. Because of the overflow the designed flow rate was reduced and the downstream could not get enough water. Downstream canal siltation was caused by uncontrolled erosion in the upstream part and noncompliance with best practises of environmental management within the catchment area.

Photo 3a: Siltation of sand (with red mark) as observed at canal in Mwenda Mtitu Irrigation scheme-Mbeya. Photo taken by Auditors on 21st July 2018

Photo 3b: Part of Themi ya Simba Irrigation scheme filled with muds. Photo taken by Auditors on 26th November 2018

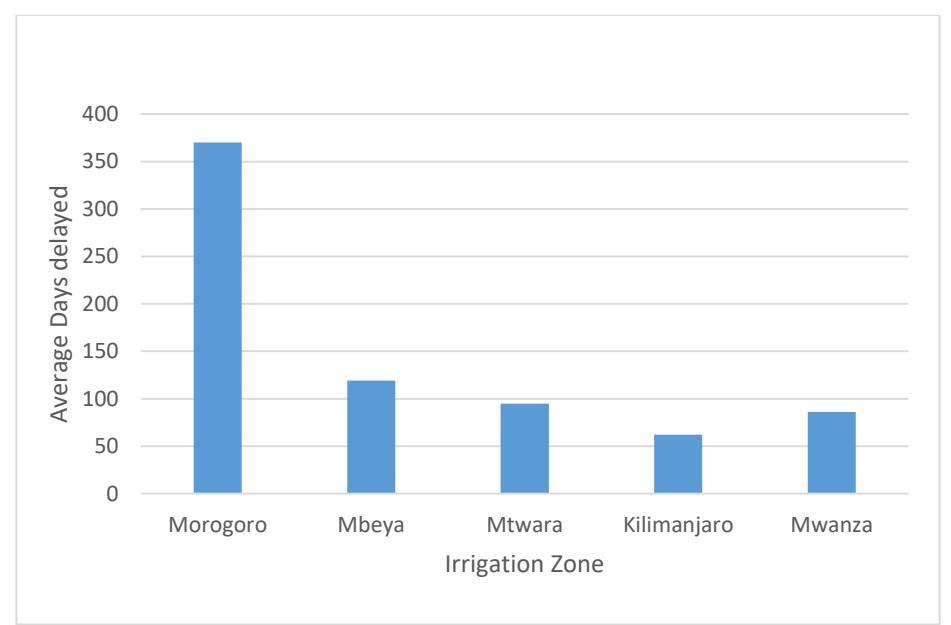
It was further noted that, average delays in completion varied from one irrigation zone to another as it is shown in **Figure 5**.

Figure 4: Average delay (Days) from visited Irrigation Zone **Source:** Auditors analysis from reviewed progress reports

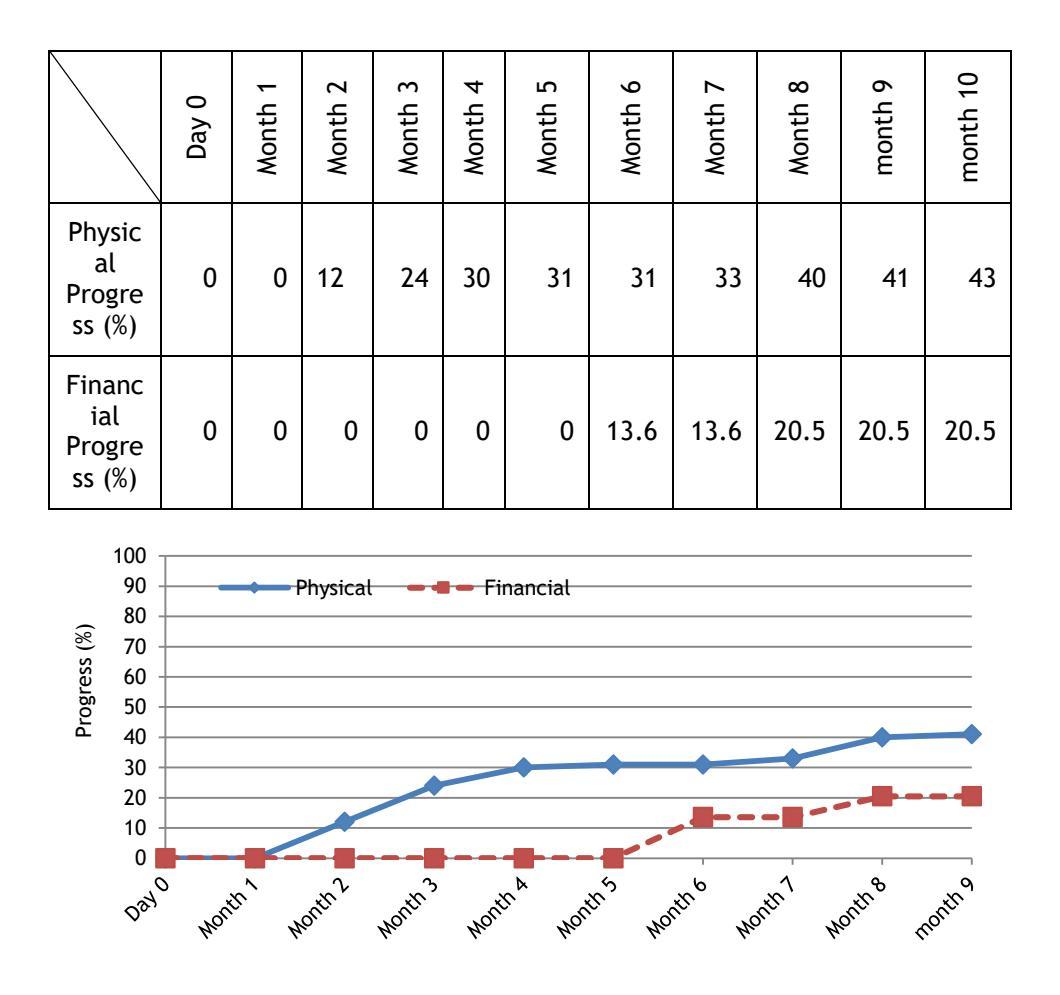
Figure 5 shows that, physical progress of project depends on the cash flow of the contractor. For this case contractor continued working without being paid for five months, where he only achieved 31 percent of physical progress. This progress was attained on the first half of contractual period. For the remaining five (5) months, contractor managed to increase only 12 percent of the physical progress making cumulative progress of 43 percent, at the time when the contract period was over, and cumulative payment made was only 20.5 percent.

Source: Monitoring sheet for Nakahuga Irrigation Scheme 30th April 2018
 Figure 5: The Impact of Financial Delays on Physical Progress of irrigation Project Implementation

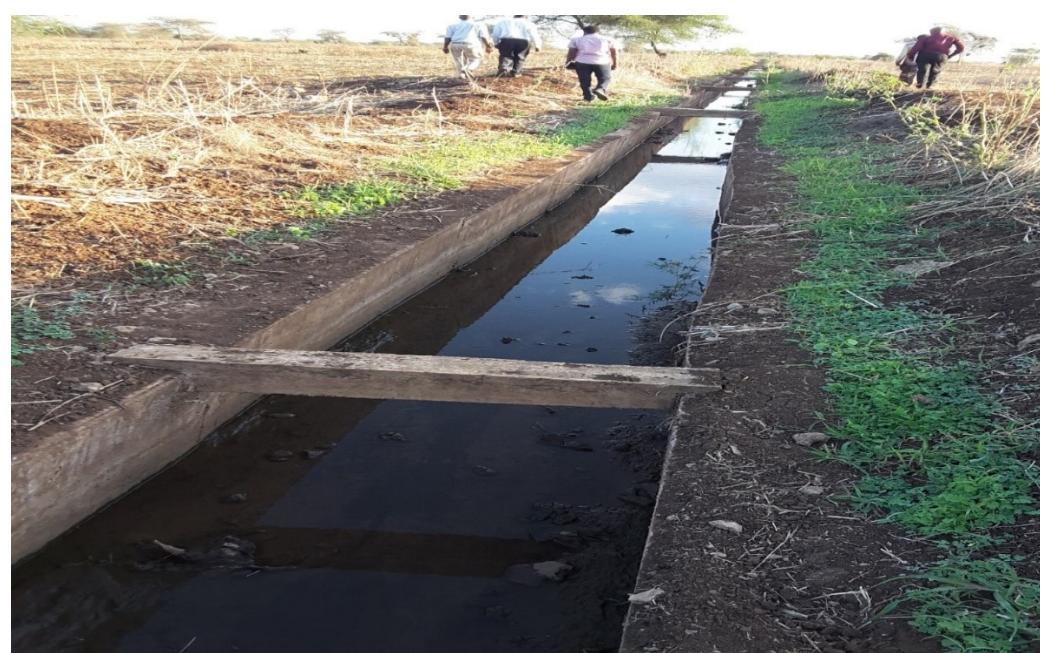
Photo 4, Themi ya Simba irrigation canal built with no distribution boxes for irrigating side farms, photo taken by auditors on 26th November 2018
