# THE UNITED REPUBLIC OF TANZANIA NATIONAL AUDIT OFFICE

# PERFORMANCE AUDIT REPORT ON THE SUPERVISION OF CONSTRUCTION OF WAREHOUSES AND STORAGE SILO COMPLEX

THE MINISTRY OF AGRICULTURE AND NATIONAL FOOD RESERVE AGENCY (NFRA)

MARCH, 2020

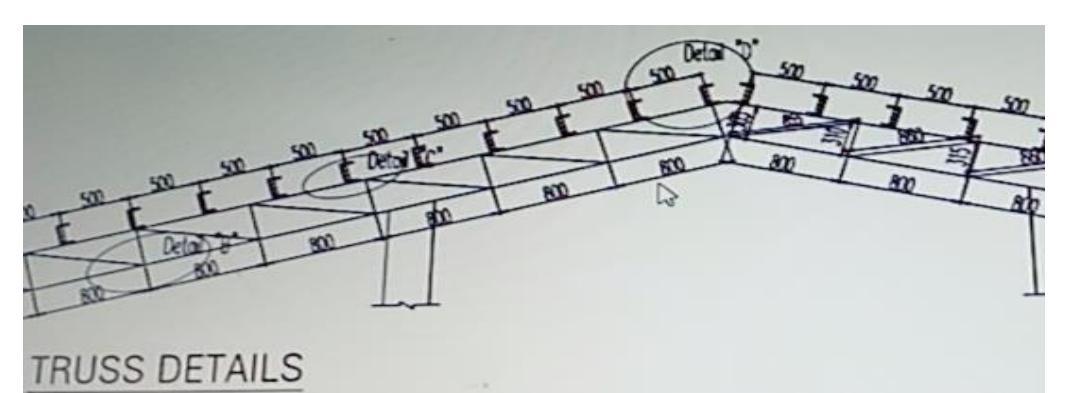
Review of structural drawings of warehouses showed that the roof trusses did not include gusset plates for strengthening trusses to safeguard the stability of the roof as shown in **Photo 3.1.**

Photo 3.1: Structural drawing of trusses without gasket plate as it was taken at Njage's structural drawing on 18<sup>th</sup> January 2020)

The shortcoming was identified during roofing stage by the Permanent Secretary of the Ministry of Agriculture who saw the risk of roof failure. This necessitated the Project Manager to instruct all contractors during the progress meetings held in December 2019 to include gusset plates to all constructed warehouses. However, the instruction was issued late because in one of the visited construction site at Kigugu in Mvomero DC, the contractor had started to mount trusses on the structure without tightening them with gusset plates. Photo 3.2a and Photo 3.2b show the trusses with and without gusset plates respectively. The addition of gusset resulted to total cost of TZS 33.5 million.

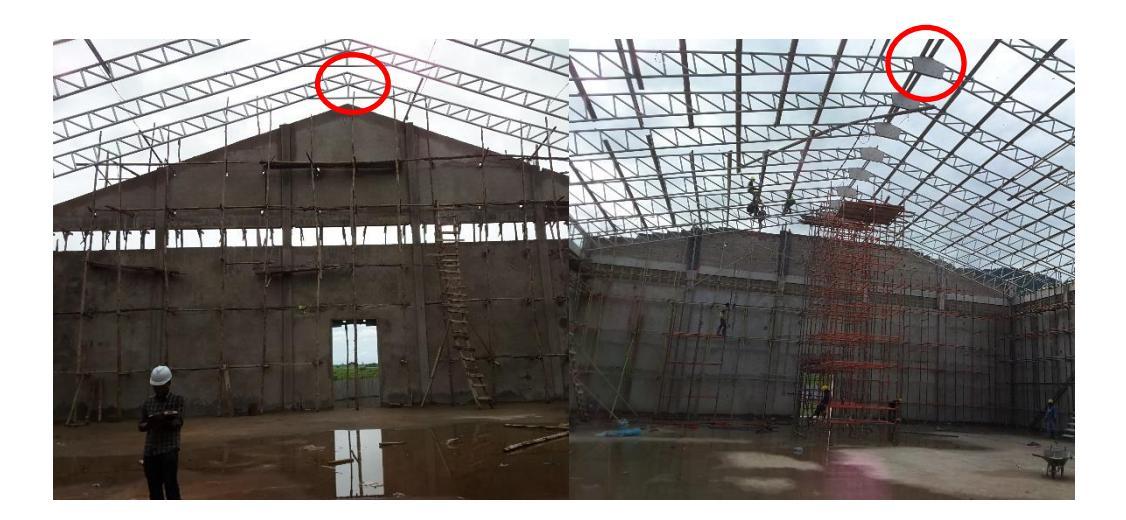
Photo 3.2a, trusses were Photo 3.2b, trusses mounted mounted atop of the warehouse atop of the warehouse structure with gasket plate (circled red) structure (circled red) without at Niage warehouse project as being tied with gusset plate at observed by auditors on 17<sup>th</sup> Kigugu warehouse project as observed by Auditors on 17<sup>th</sup> January 2020 at 4:58 pm. January 2020 at 2:56 pm.

Roof trusses without gusset plates have a high risk of collapsing which may lead to injury, damage to stored crops and high cost of re-building.

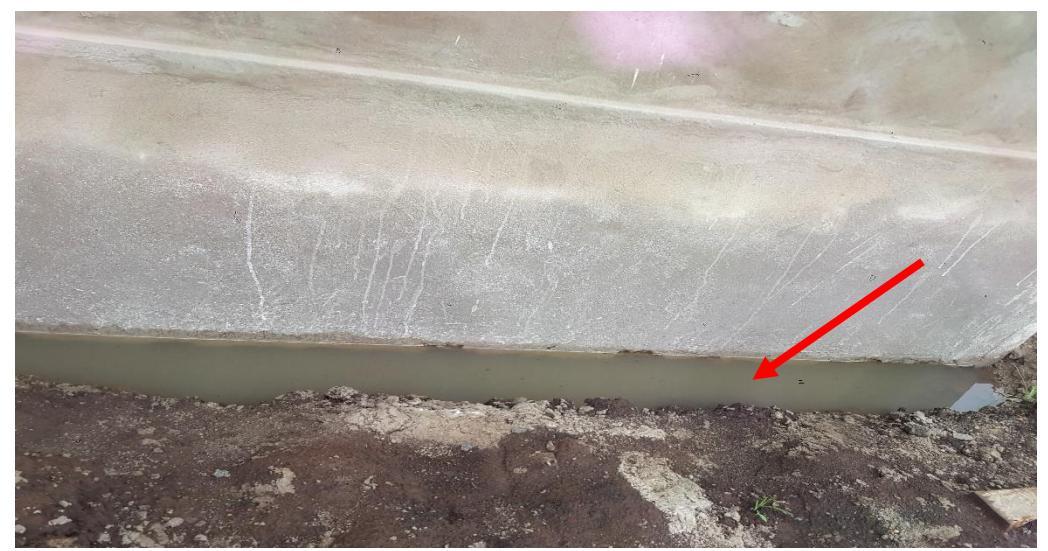
The same scenario was noted at Mbogo-Komtonga warehouse in Mvomero which was built within a high water table area. The visit made to this warehouse revealed water emerging from the foundation of the warehouse's office block (See Photo 3.3).

**Photo 3.3:** Water emerged from the ground and logged at the foundation (see red arrow) at Mbogo-Komtonga warehouse in Mvomero DC. Photo was taken by auditors on 16<sup>th</sup> January 2020 at 1:03 pm.

Constructing warehouses along water stream and high water table might result into settlements and destruction of the structure in case of floods. Also high water table beneath the foundation might cause dampness of the foundation, and bringing moisture to the stored grains.

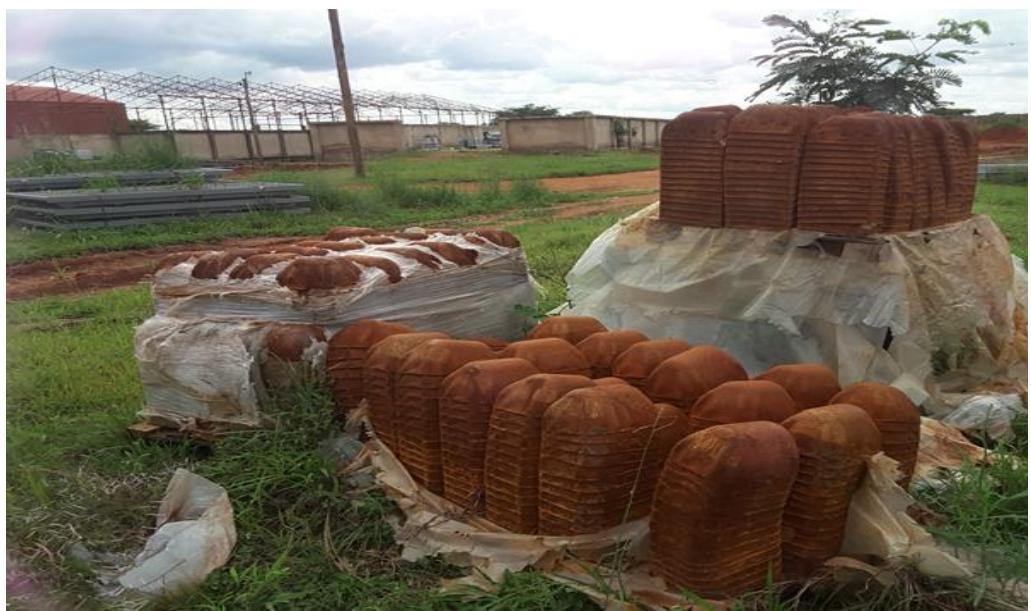
The noted impact of delay in payments to Contractors include suspension of works. According to Quarterly Progress Report of January 2020 Contractors suspended construction work in the all five sites for more than two months. Delay in payments slowed the work and sometimes the tools used for the construction were damaged due to long stay without being used. This was observed at Shinyanga where different silo tools shown in **Photo 3.4**, got rusted due to long storage that rendered them not suitable for use.

**Photo 3.4:** Rusted Silo elements due to long storage caused by stoppage of construction. Photo taken at Shinyanga Construction Lot on 27<sup>th</sup> January 2020 at 3:31 p.m.

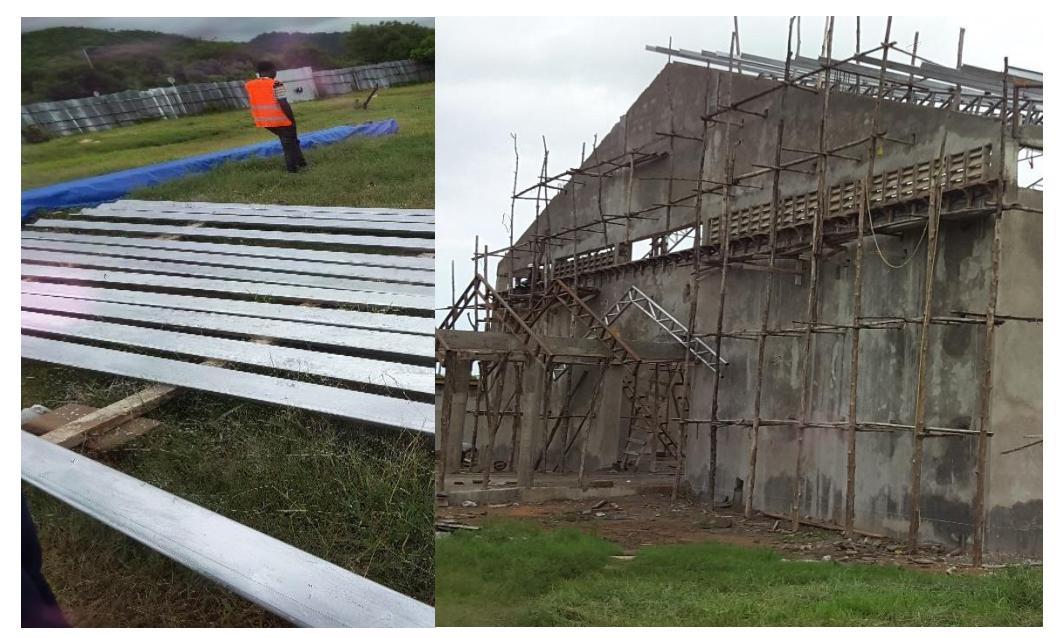
Further, observations made at Kigugu Warehouse Project, also revealed similar cases of the Project Manager not being at the site as required. Due to absence of the Project Manager, there were roof trusses which were already mounted and only painted with silver color coat and ignoring the Red Oxide under coat color. Since this activity collided with the site meeting activity, then the Project Manager identified the discrepancy before much work was done and issued instructions of ensuring that Red Oxide is painted first as the under coat before painting the silver color. See Photo 3.5(a) and 3.5(b) for more details.

Photo 3.5(a) Metal purlins for roofing painted silver color Red Oxide without as the under coat. Photo was taken at Kigugu construction site on 16 **Photo 3.5(b),** Roofing in progress with the trusses painted silver instead of Red Oxide as the under coat. Photo taken at Kigugu construction site on 16 January 2020 at 2:52 pm.

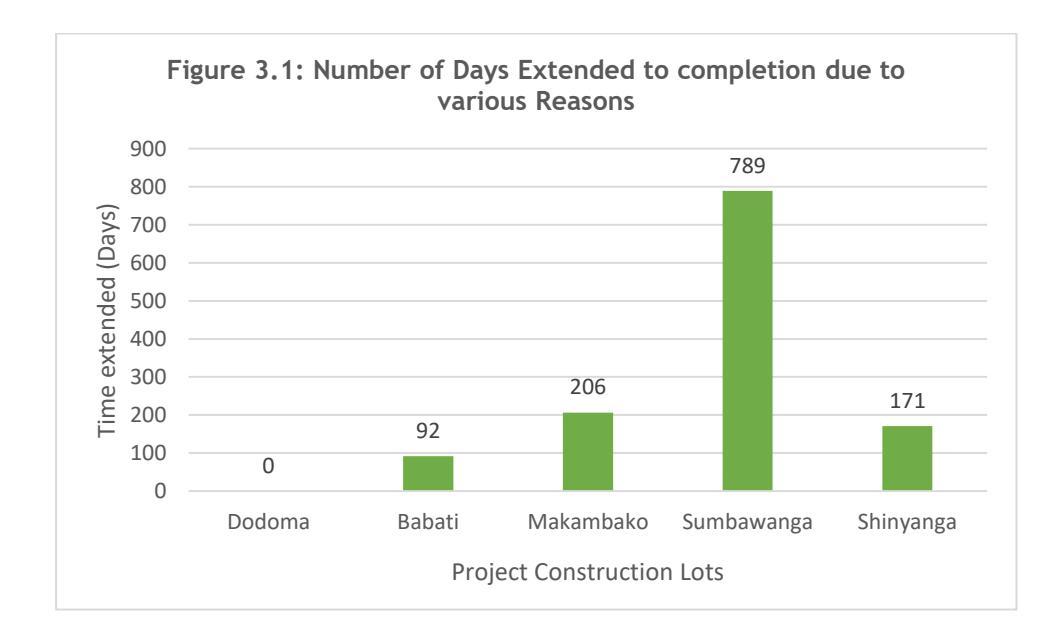
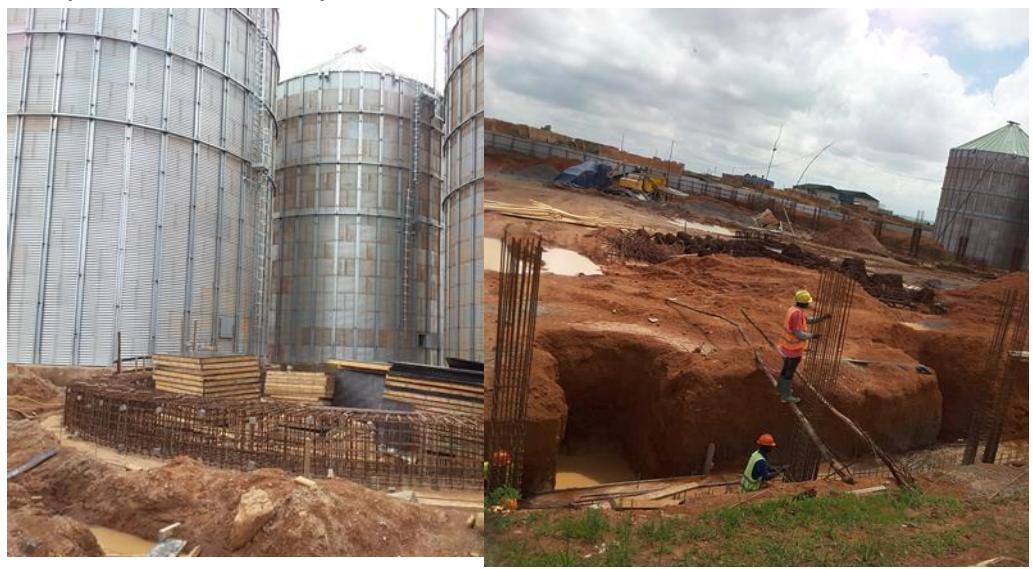
The project delays were also identified for the Expansion Storage Capacity Projects. To the time of this audit, four (4) out of five (5) reviewed projects had time extension ranging from 92 to 789 days. Only Dodoma site remained on its original completion date as shown in **Figure 3.1**. With the exception of Dodoma Construction site, other construction sites of Package A the Contractor had not erected superstructures for warehouses, laboratories and offices being part of the contract as shown in **Photo 3.6 a and b**.

However, through the site visit to different construction sites, auditors noted that, progress seemed to be better for silo complex and worse for other project components. The progress was noted to range from 75 to 80 percent for storage silo complex under Package A Contractor, while for Package B Contractor the progress was more than 70 percent with the exception of Sumbawanga Storage silo complex which had 6 percent.

**Photo 3.6 a:** The Progress of Storage silo complex in construction process at Makambako. Photo taken on 20<sup>th</sup> January 2020 on 2:09 P.M

**Photo 3.6 b:** The Progress of Warehouse construction (only foundation) at Makambako. Photo taken on 20<sup>th</sup> January 2020 on 2:04 P.M
